EVALUATION OF ARTIFACTS ORIGINATING FROM SOUTH EAST ASIA AIRCRAFT LOSS SITES

SUBJECT: EVALUATION OF LIFE SCIENCES EQUIPMENT ARTIFACTS

ARTIFACT LOT: 1
ARTIFACT TOTAL IN LOT: 465
BATCH IDENTIFICATION: ANALYST ASSIGNED
JTF-FA REFNO CASE NUMBER: 1374
DATE ANALYSIS COMMENCED: 01 AUGUST 2001

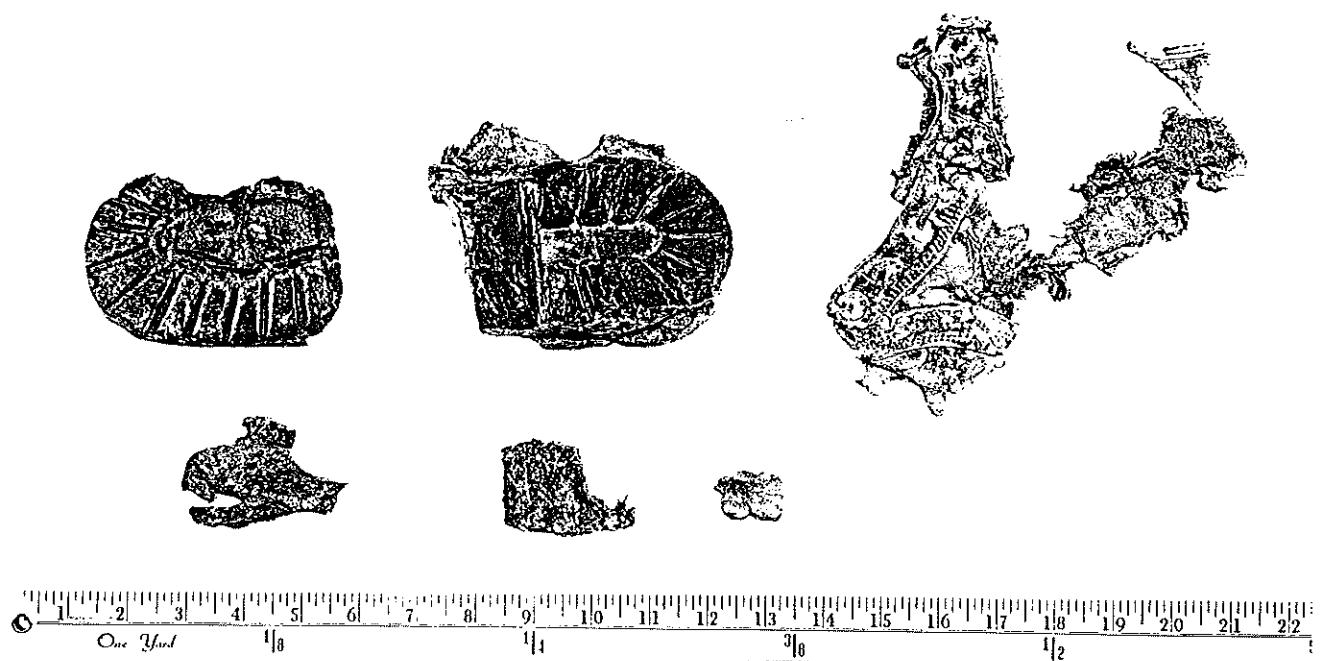
Six artifacts submitted for analysis (Picture 1 below) were provisionally identified as being comparable with a Boot, Combat, Tropical. The official designation for this particular type of outer foot wear is: Boot, Combat, Tropical, Mans, Leather and Nylon Duck, Direct Molded Sole, Spike Resistant, manufactured in accordance with Military Specification MIL-B-43154. (Hereafter referred to as the 'Tropical Combat Boot').

JTF-FA CASE: 1374PICTURE 1. THE TROPICAL COMBAT BOOT ARTIFACTS.

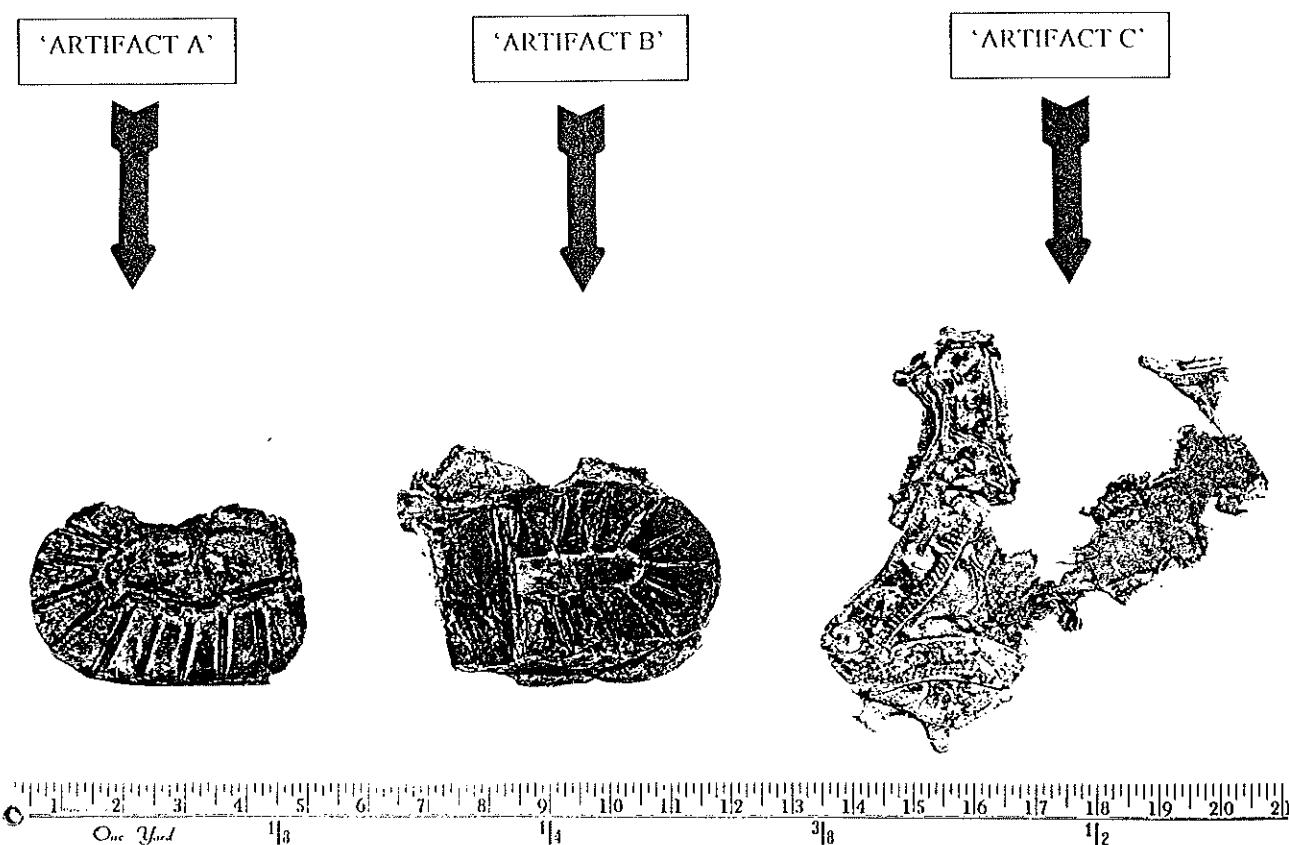
Picture 2 below, depicts three artifacts (from the original six artifacts sent in for analysis – refer to Picture 1, Page 1-1) that have been selected for further discussions within this section of the report. These artifacts are identified as: 'Artifact A', 'Artifact B', and 'Artifact C'.

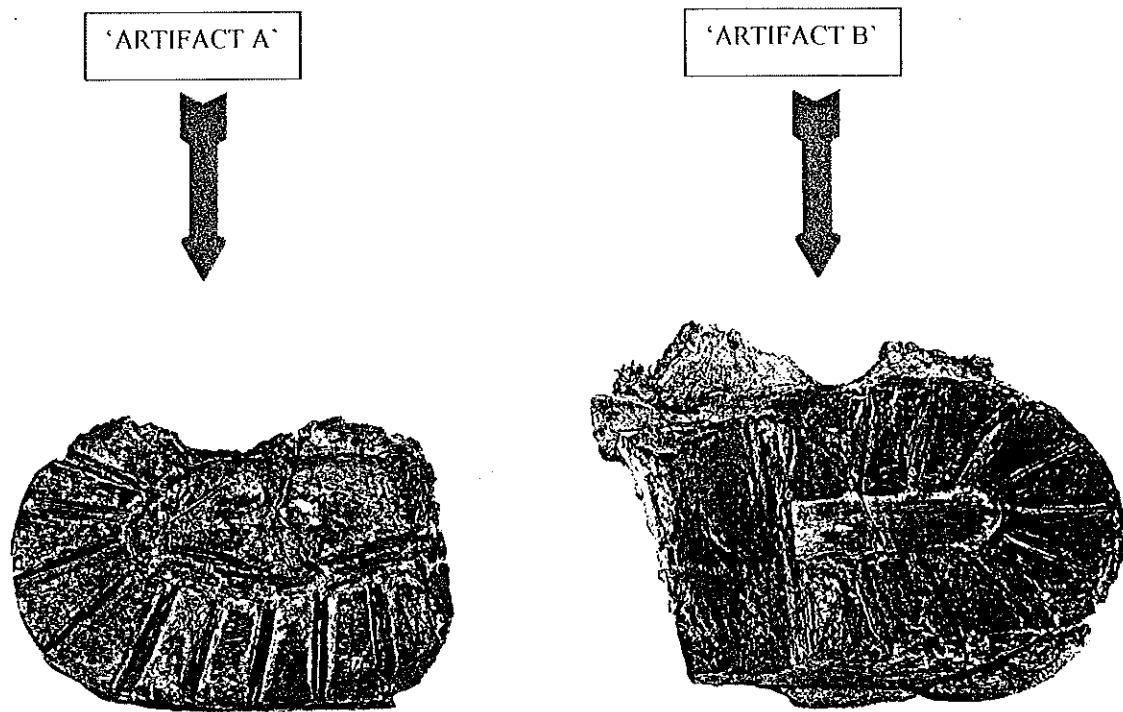
Picture 3 below, is a close-up view of 'Artifact A' and 'Artifact B' (refer to Picture 2, Page 1-2). These artifact display very distinguishable characteristics that unmistakably match the fully cleated sole and heel patterns of a Master Reference Tropical Combat Boot retained within the Life Sciences Equipment Laboratory.

PICTURE 3. A CLOSE-UP VIEW OF 'ARTIFACT A' AND 'ARTIFACT B'.

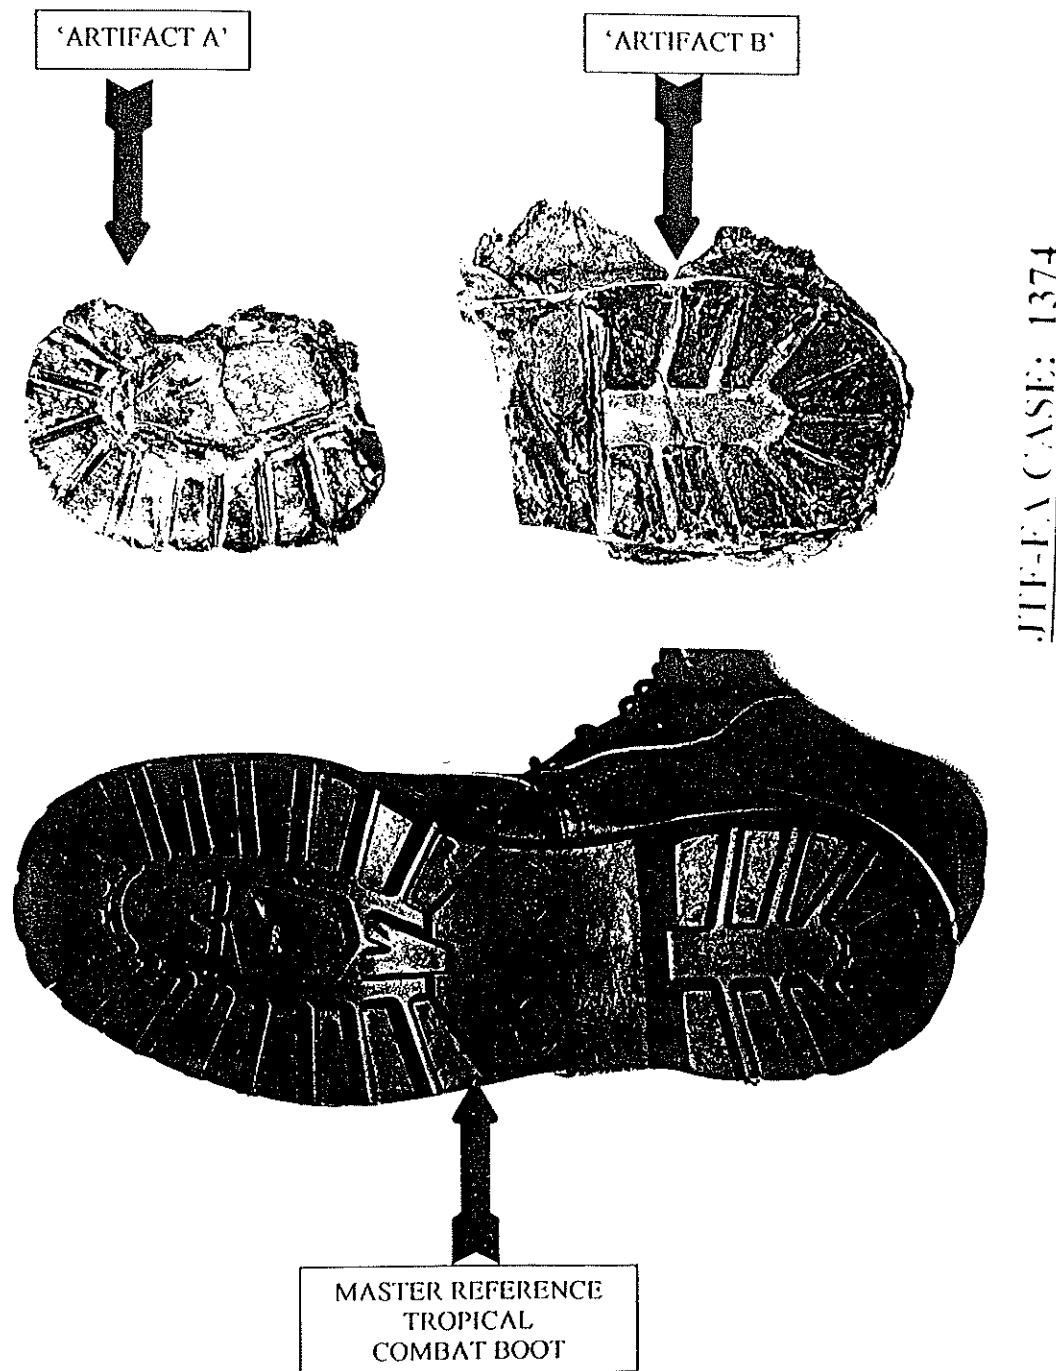
In Picture 4 below, 'Artifact A' and 'Artifact B' are positioned adjacent to the correlating area of origin on a Master Reference Tropical Combat Boot.

PICTURE 4. A VIEW OF 'ARTIFACT A' AND 'ARTIFACT B' POSITIONED
ADJACENT TO THE CORRELATING AREA OF ORIGIN ON A MASTER
REFERENCE TROPICAL COMBAT BOOT.

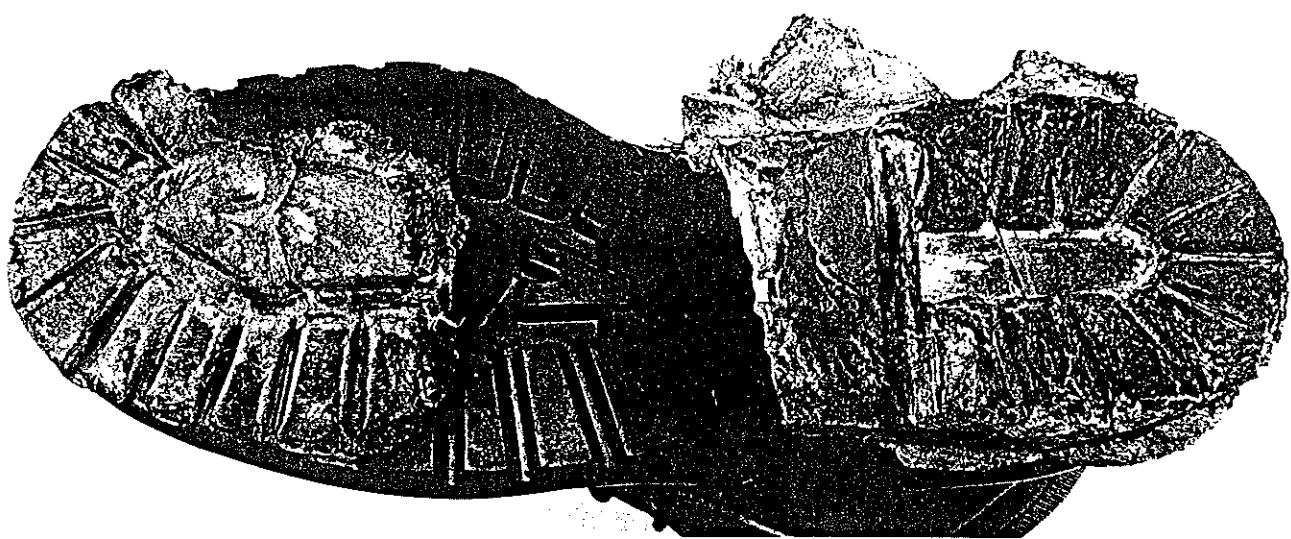
In Picture 5 below, 'Artifact A' and 'Artifact B' are overlaid onto the sole and heel region of the Master Reference Tropical Combat Boot. (These artifacts are consistent with the sole and heel of a boot that would be worn on the right foot.)

PICTURE 5. A VIEW OF 'ARTIFACT A' AND 'ARTIFACT B' OVERLAID ONTO
THE SOLE AND HEEL REGION OF THE MASTER REFERENCE TROPICAL
COMBAT BOOT.

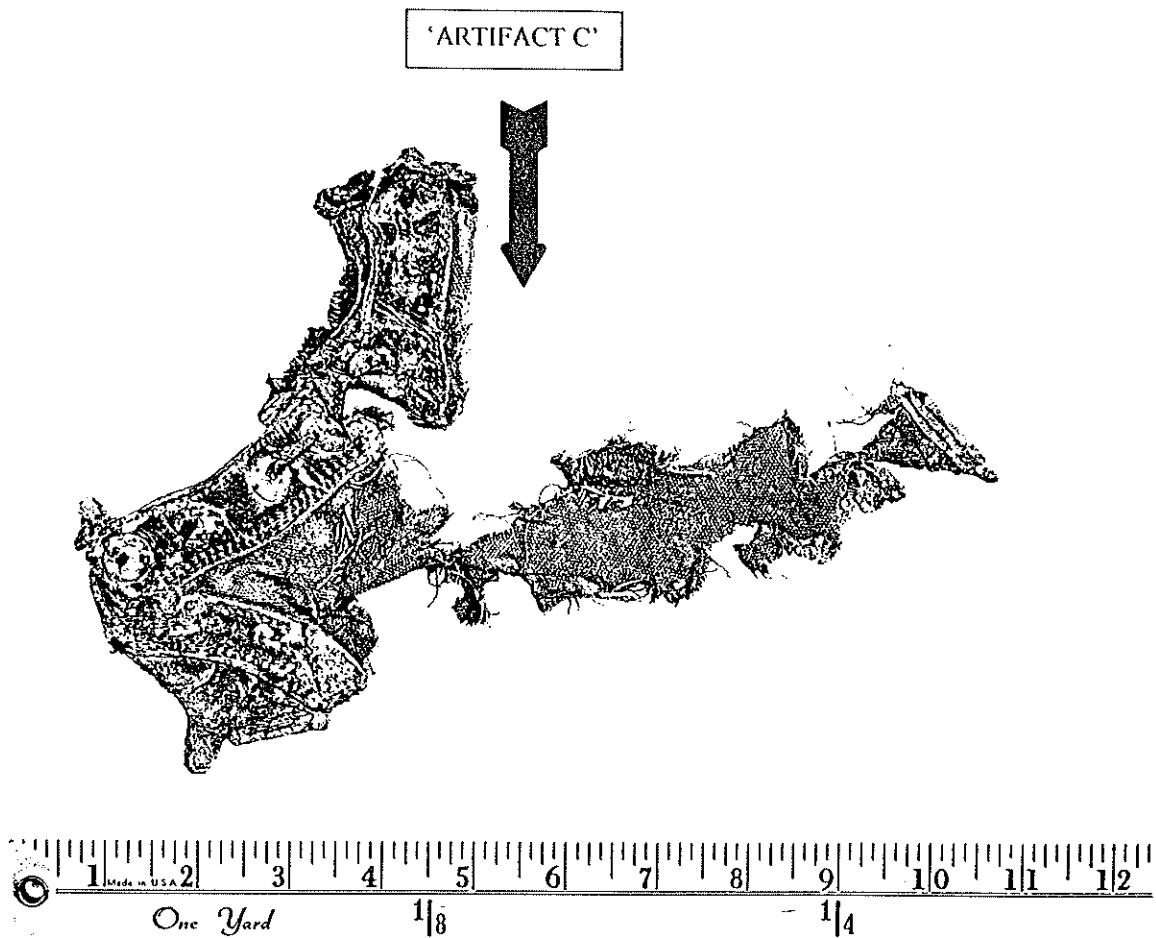
Picture 6 below, is a close-up view of 'Artifact C' (refer to Picture 2, Page 1-2). This artifact displays very distinguishable characteristics that unmistakably match areas associated to the vamp (lower section) portion of the Tropical Combat Boot, as well as areas associated with the lacing loop segment of the boot.

PICTURE 6. A CLOSE-UP VIEW OF 'ARTIFACT C'

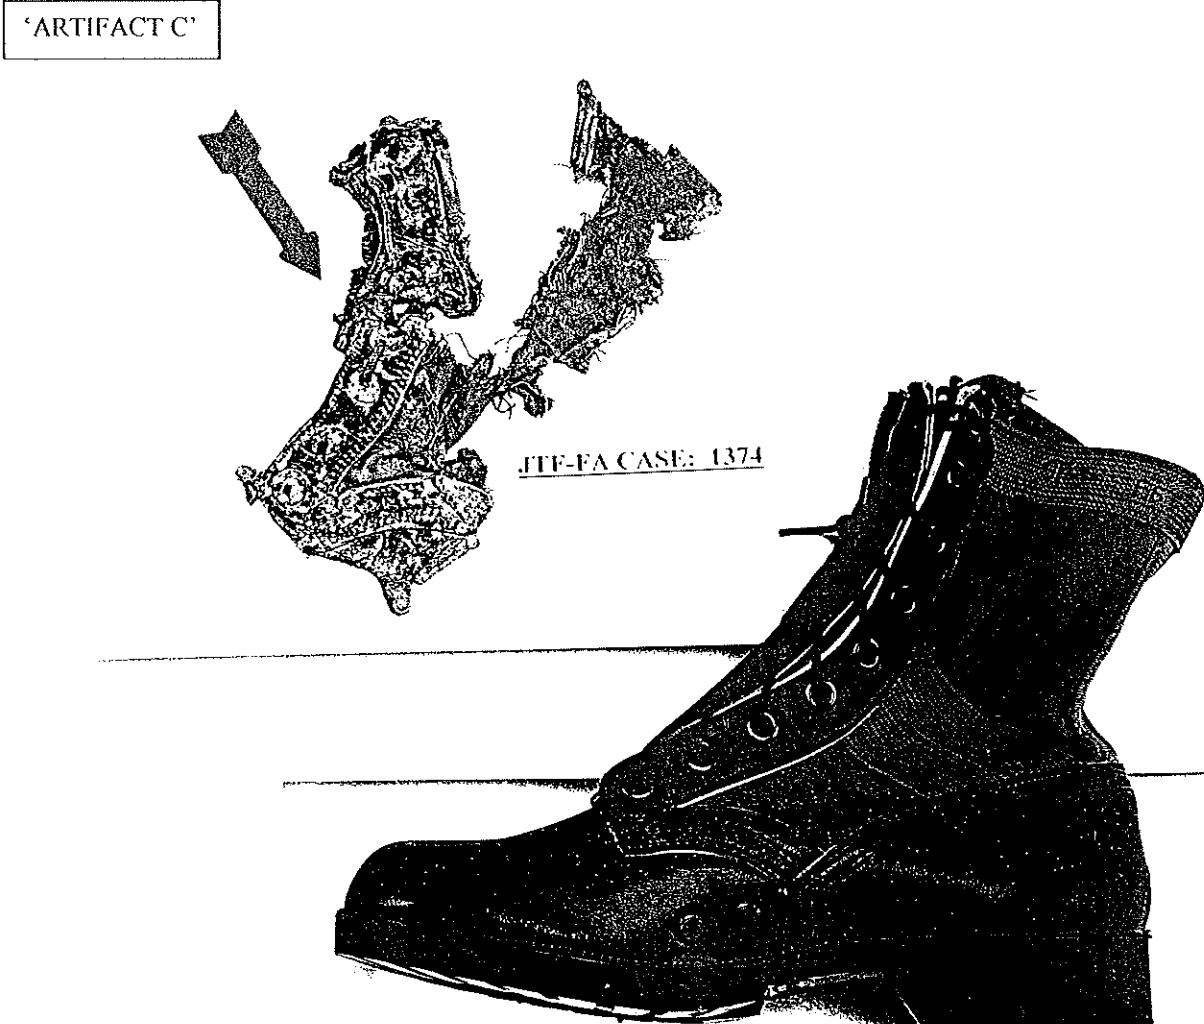
In Picture 7 below, 'Artifact C' is positioned adjacent to the correlating area of origin on a Master Reference Tropical Combat Boot.

NOTE: The black dotted ink markings on the attached Mylar overlay represent stitching patterns securing the lightweight cotton and nylon duck material of the quarter section to the leather vamp material of 'Artifact C'. These are in direct relationship to the stitch patterns visible on the Master Reference Tropical Combat Boot (also highlighted with black dotted ink markings). In addition to these highlighted stitch patterns, observe the alignment of the highlighted lacing loop grommets on 'Artifact C' in relationship to the highlighted lacing loop grommets on the Master Reference Tropical Combat Boot.

PICTURE 7. A VIEW OF 'ARTIFACT C' POSITIONED ADJACENT TO THE CORRELATING AREA OF ORIGIN ON A MASTER REFERENCE TROPICAL COMBAT BOOT.

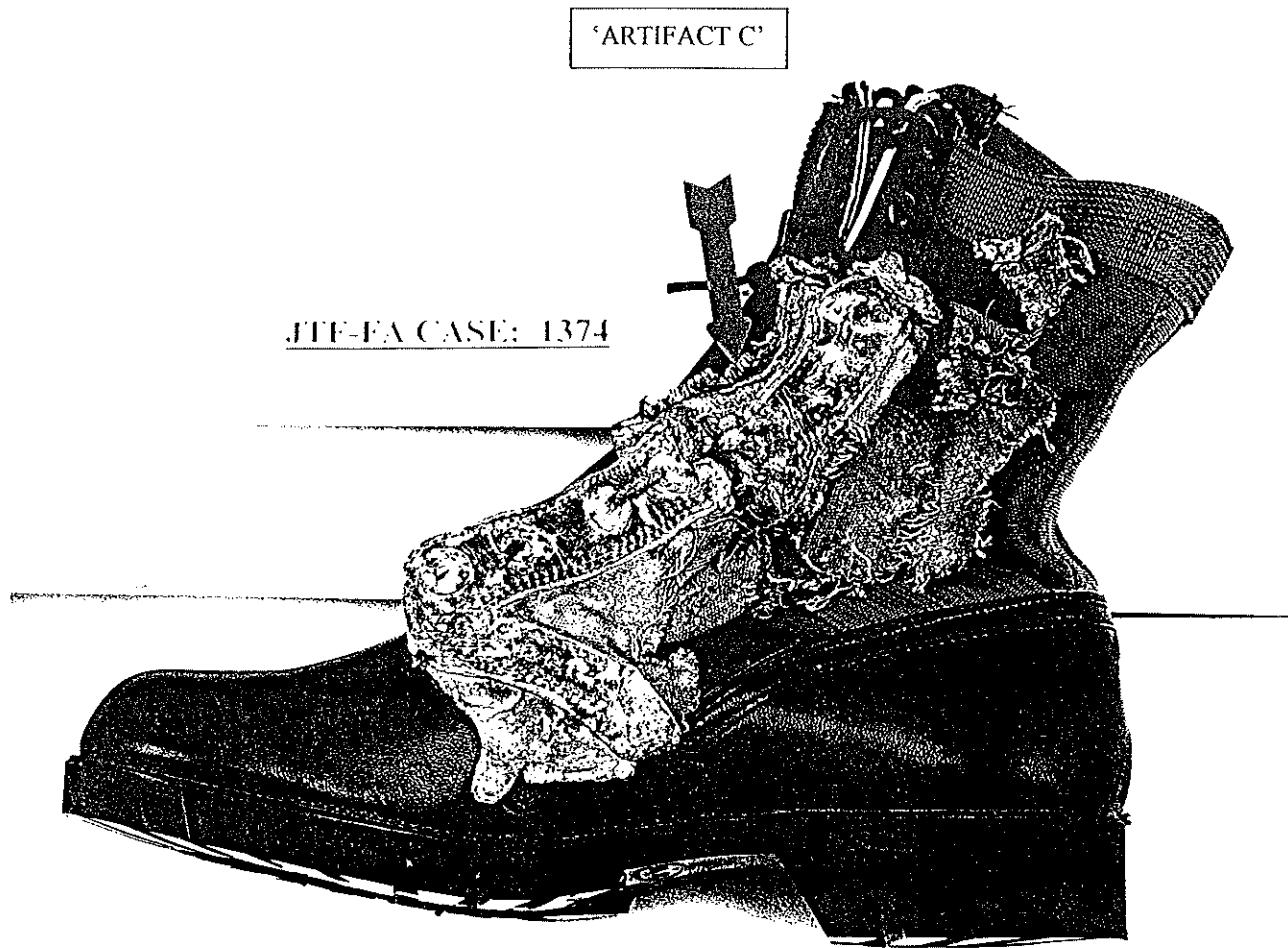
In Picture 8 below, 'Artifact C' is overlaid onto the region of origin on the vamp segment of the Master Reference Tropical Combat Boot.

PICTURE 8. A VIEW OF 'ARTIFACT C' OVERLAI
D ONTO THE AREA OF ORIGIN
ON THE MASTER REFERENCE TROPICAL COMBAT BOOT.

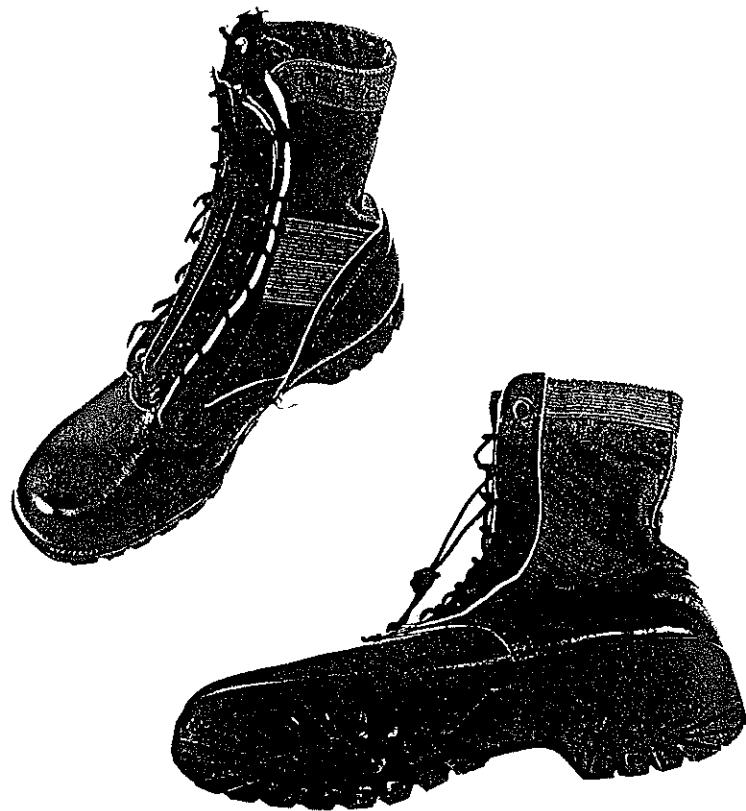
PICTURE 9. THE MASTER REFERENCE TROPICAL COMBAT BOOTS.

Picture 9 below, displays the Master Reference Tropical Combat Boots that were used in the analysis of the artifacts for this section.

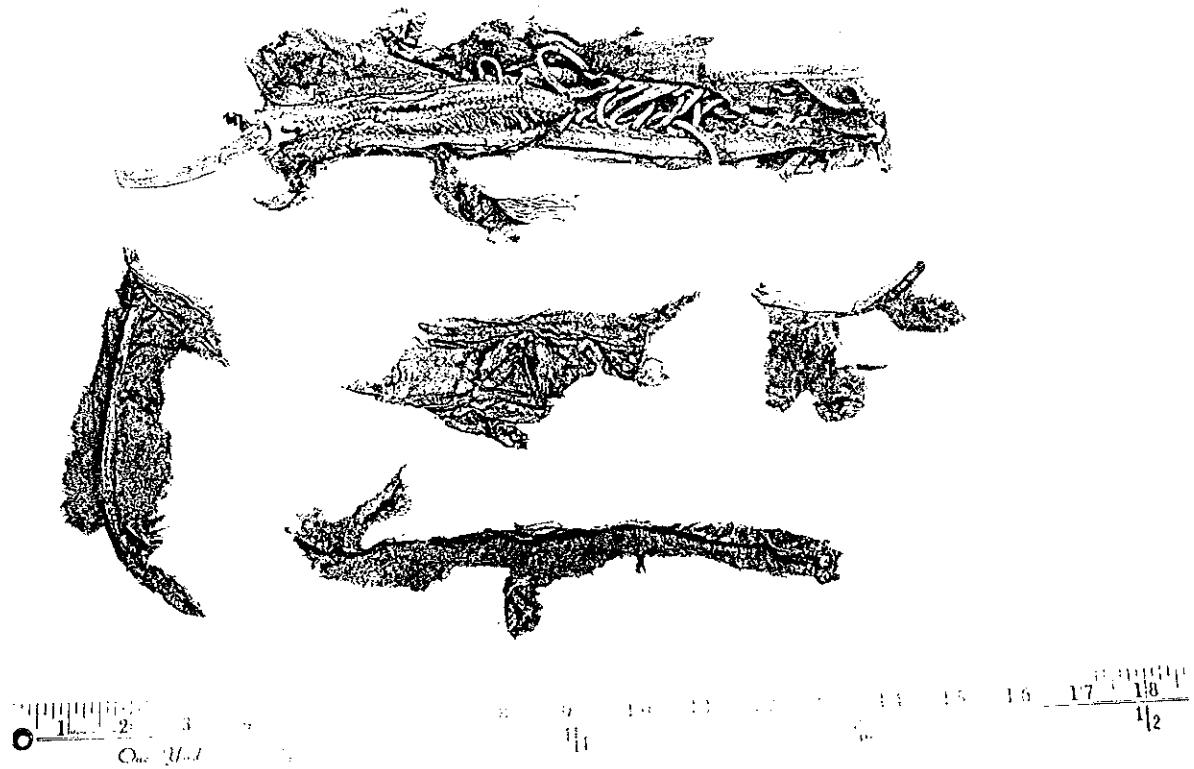
Picture 1 below, depicts the five artifacts that have been identified as being comparable to materials used in the construction of a Military Specification MIL-A-25892, Anti-G Garment, Cutaway, Type CSU-3/P (hereafter referred to as the "Anti-G Suit").

PICTURE 1. THE ARTIFACTS ATTRIBUTED TO THE 'ANTI-G SUIT'.

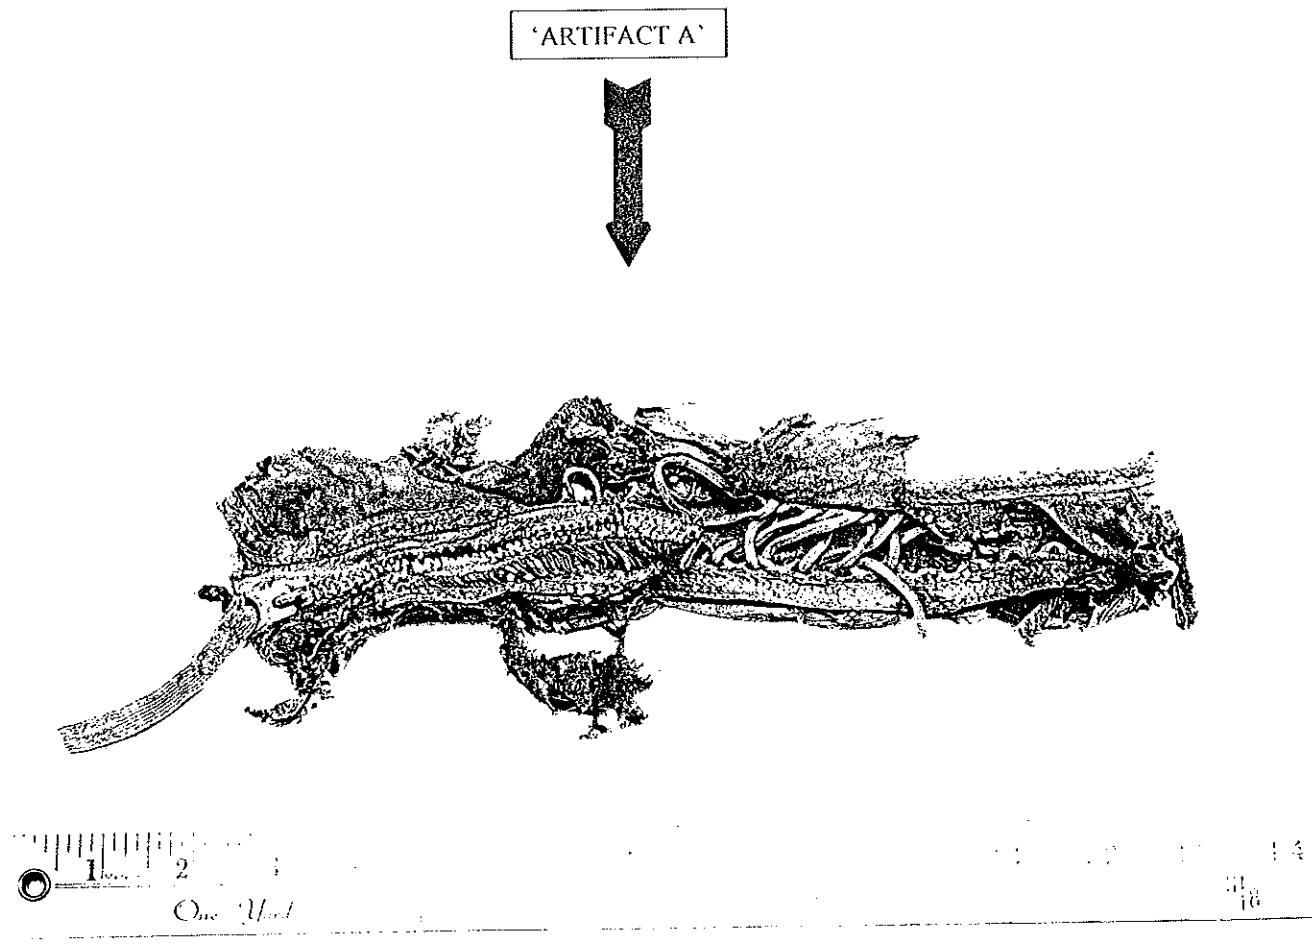
Picture 2 below, is a close up view of one of the artifacts depicted in Picture 1, Page 2-1. This artifact (identified as 'Artifact A') was selected for photographic comparisons, due to identifiable matching characteristics to a Master Reference Anti-G Suit that is retained within the Life Sciences Equipment Laboratory (LSEL).

PICTURE 2. A CLOSE-UP VIEW OF 'ARTIFACT A'.

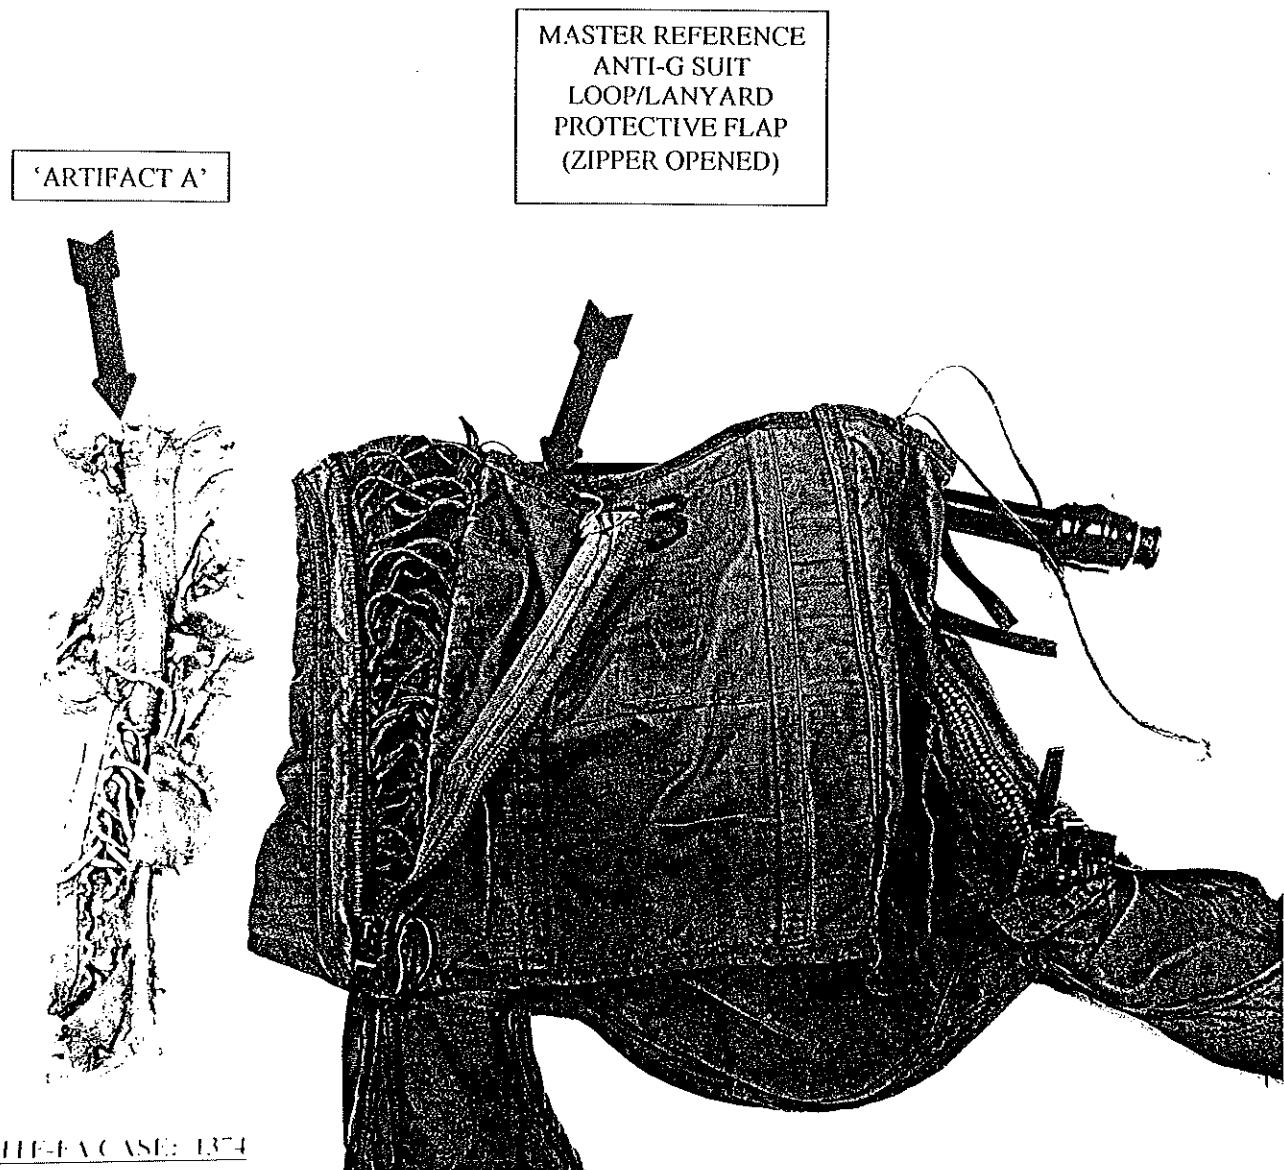
In Picture 3 below, 'Artifact A' is positioned adjacent to a correlating area of origin in the waist area of the Master Reference Anti-G Suit.

PICTURE 3. A VIEW OF 'ARTIFACT A' POSITIONED ADJACENT TO A CORRELATING AREA OF ORIGIN ON THE WAIST AREA OF THE MASTER REFERENCE ANTI-G SUIT (PROTECTIVE ZIPPER FLAP OPENED).

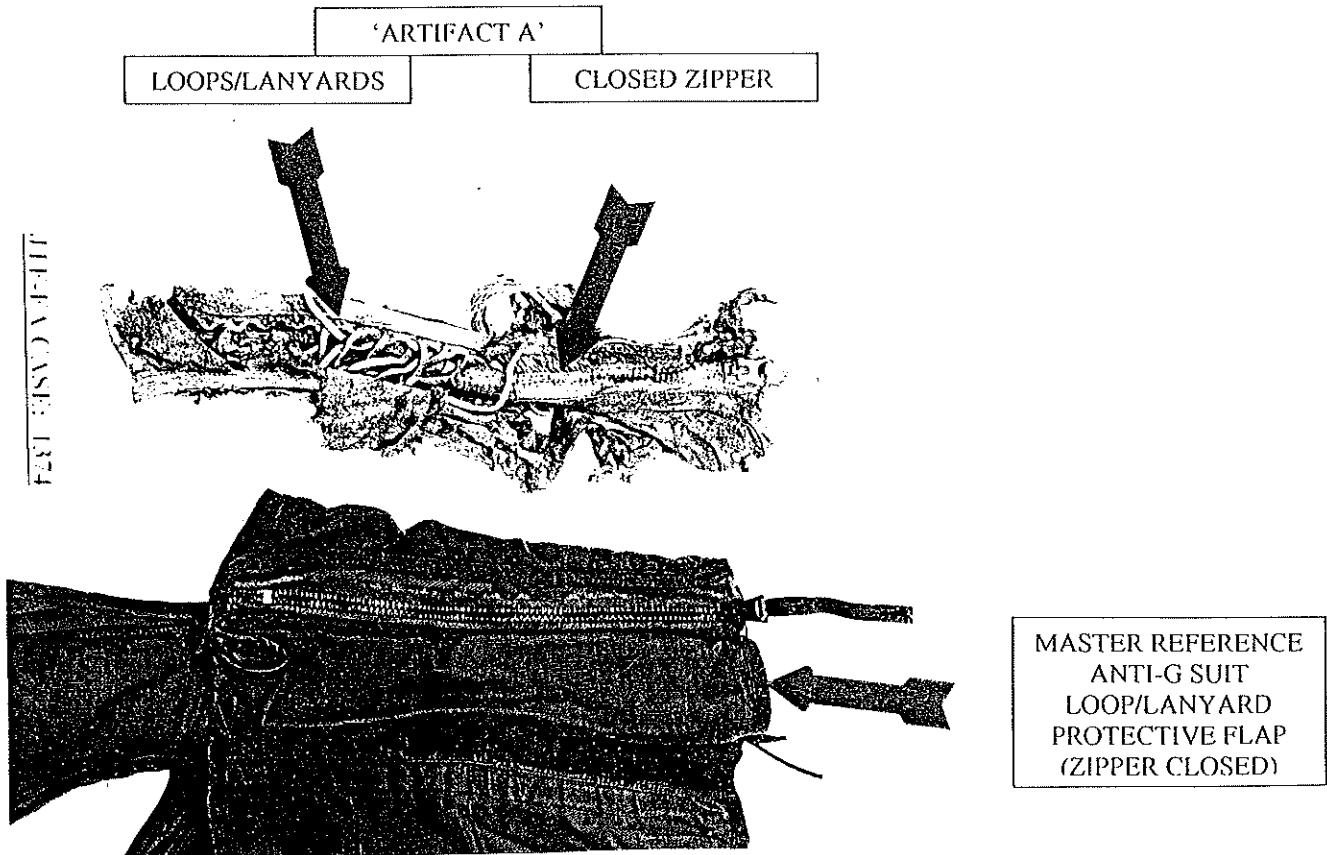
Picture 4 below, is comparable to Picture 3, Page 2-3 (picture rotated), in that it displays 'Artifact A' positioned adjacent to the same correlating area of origin in the waist area of the Master Reference Anti-G Suit.

- However, closer observation of Picture 3, reveals that the physical characteristic of 'Artifact A' is in contrast to the profile of the waist adjustment section of the Master Reference Anti-G suit – in that the lower half of 'Artifact' reveals a segment of adjustment lacing loops and lanyards (loops/lanyards). Under normal conditions, these loops/lanyards are concealed under the zippered protective flap (as is evident in the highlighted (red arrow) view of the Master Reference anti-g suit). This asymmetrical appearance to 'Artifact A' is the direct result of dynamic loading having been imposed on this section of the Anti-G Suit – causing the lower half of the zipper protective flap be torn away.

PICTURE 3. A VIEW OF 'ARTIFACT A' POSITIONED ADJACENT TO A CORRELATING AREA OF ORIGIN ON THE WAIST AREA OF THE MASTER REFERENCE ANTI-G SUIT (PROTECTIVE ZIPPER FLAP CLOSED).

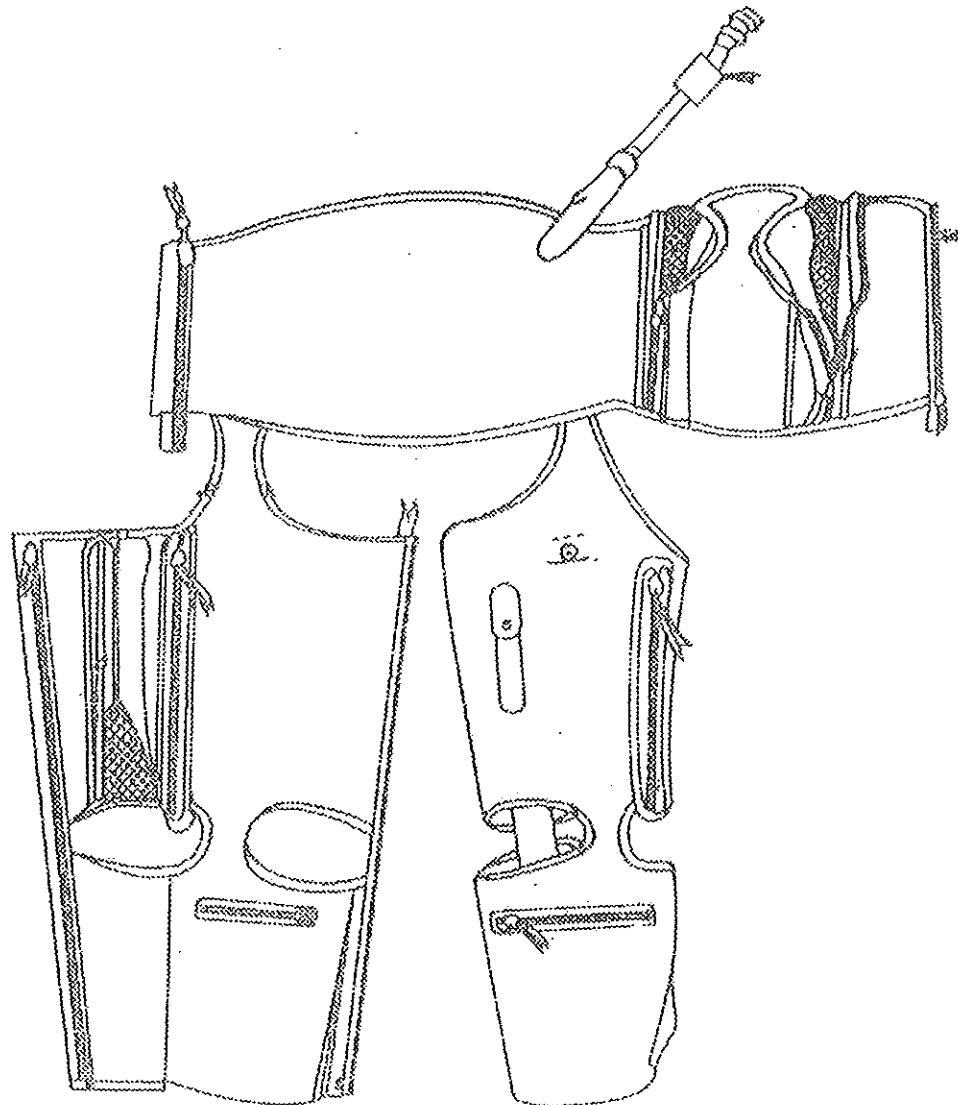
Illustration 1 below, is a schematic drawing of a typical CSU-3/P anti-g suit. The waist adjustment area (containing the internal lacing loops and lanyards) discussed within this section of the report is highlighted in yellow.

ILLUSTRATION 1. A SCHEMATIC DRAWING OF THE
ANTI-G SUIT, TYPE CSU-3/P

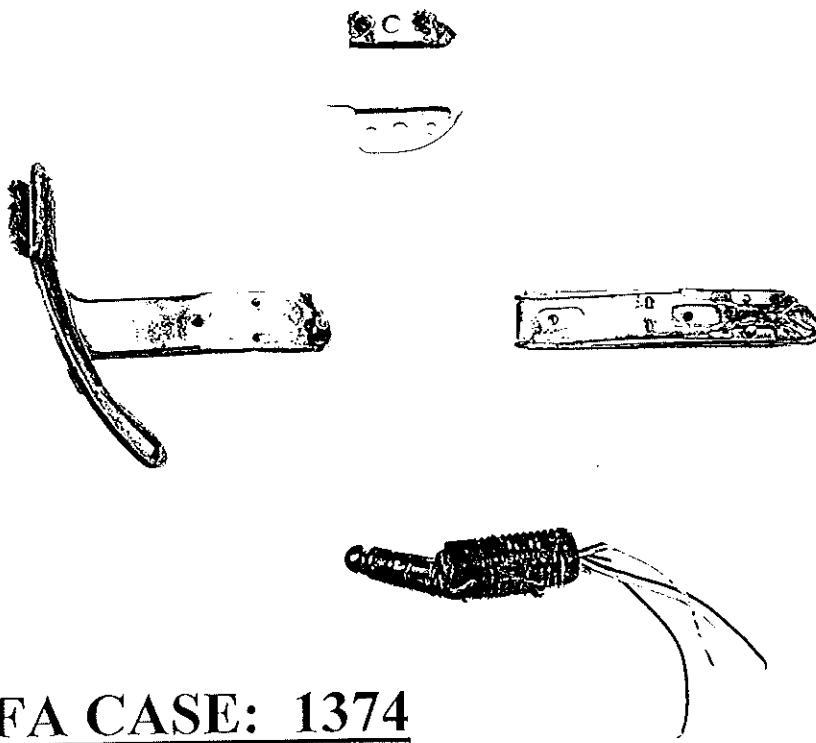
Four artifacts submitted for analysis (Picture 1 below) were provisionally identified as being comparable to subassemblies associated with a U.S. Air Force Flight Helmet, and Oxygen Mask.

PICTURE 1. THE FLIGHT HELMET AND OXYGEN MASK ASSOCIATED ARTIFACTS.

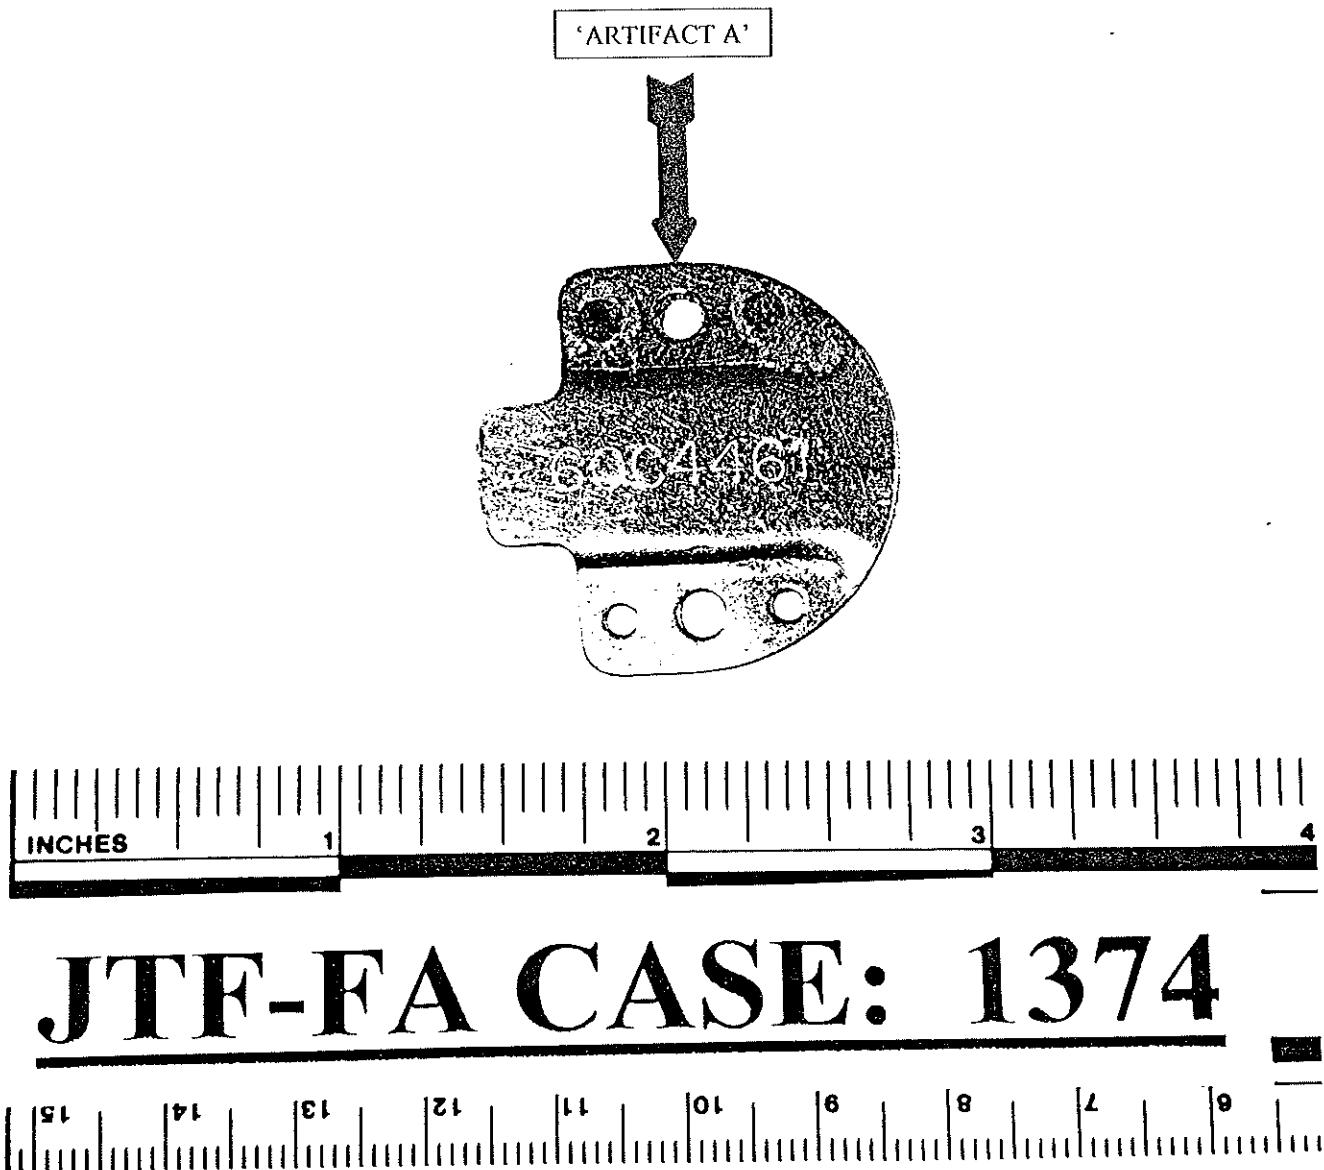
Picture 2 below, depicts a single artifact ('Artifact A') that has been identified as being comparable to a (one of two) receiver jaw that is used in the construction of an Oxygen Mask Retention Receiver Assembly – an integral component of the U.S. Air Force Type HGU-2A/P Flight Helmet (hereafter referred to as the 'flight helmet').

PICTURE 2. A CLOSE-UP VIEW OF 'ARTIFACT A'.

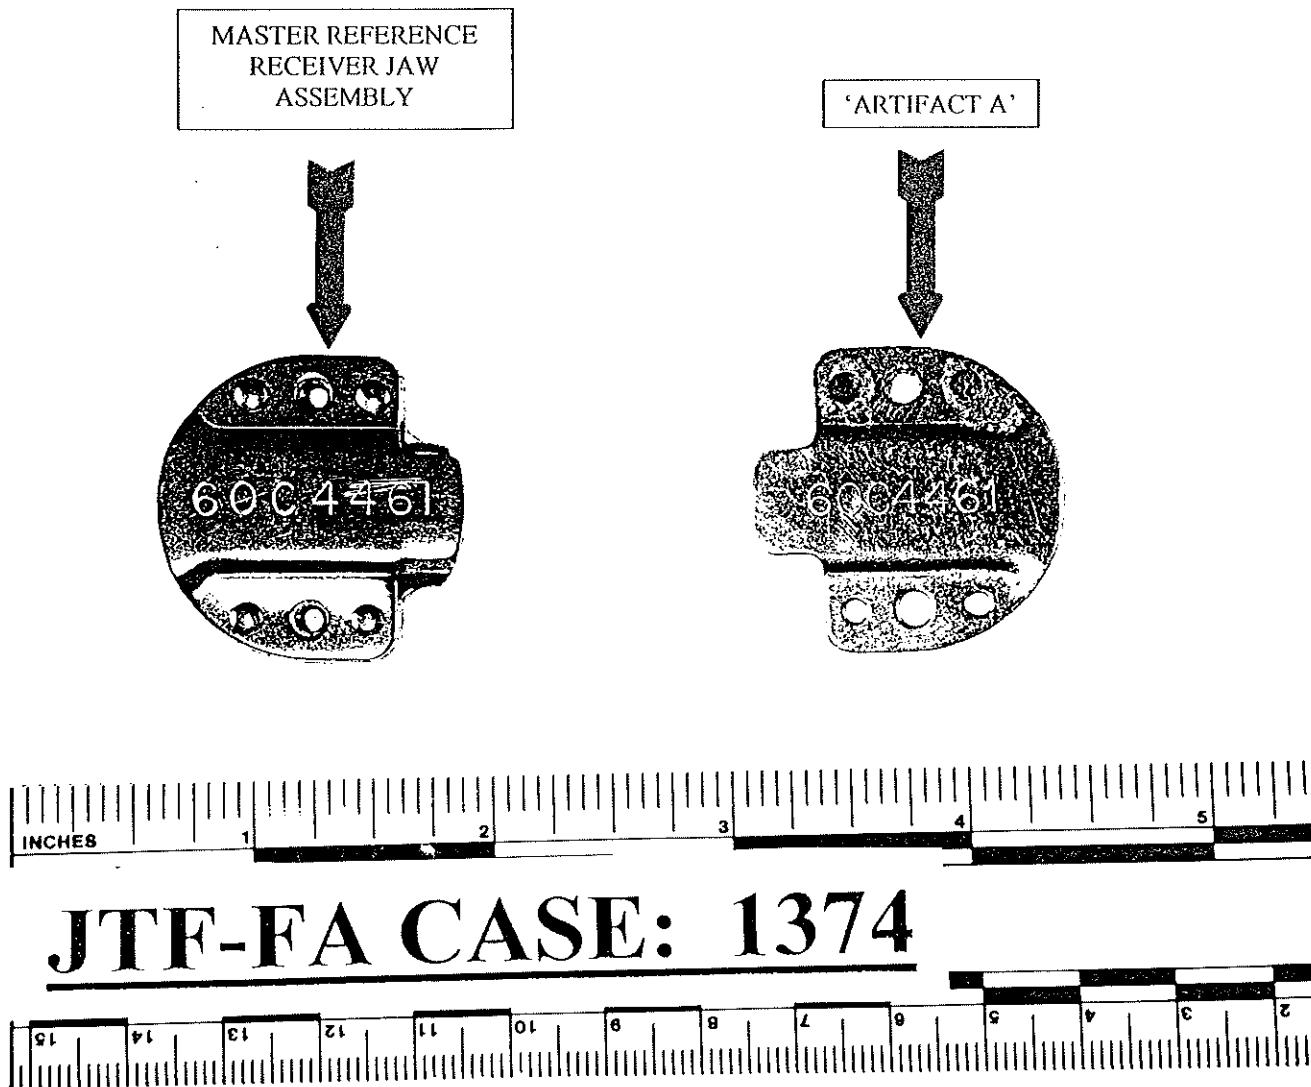
In Picture 3 below, 'Artifact A' is positioned adjacent to a Master Reference Receiver Jaw Assembly, an integral component of the Oxygen Mask Retention Receiver Assembly (hereafter referred to as the 'receiver assembly'). As depicted in this picture, both elements are similar in size, and profile. In addition to these physical similarities, both 'Artifact A', and the Master Reference Receiver Assembly, are permanently stamped with Part Number '60C4461', which positively identifies 'Artifact A' as being a subcomponent of a time period receiver assembly.

PICTURE 3. A VIEW OF 'ARTIFACT A' POSITIONED ADJACENT TO A MASTER
REFERENCE RECEIVER JAW ASSEMBLY.

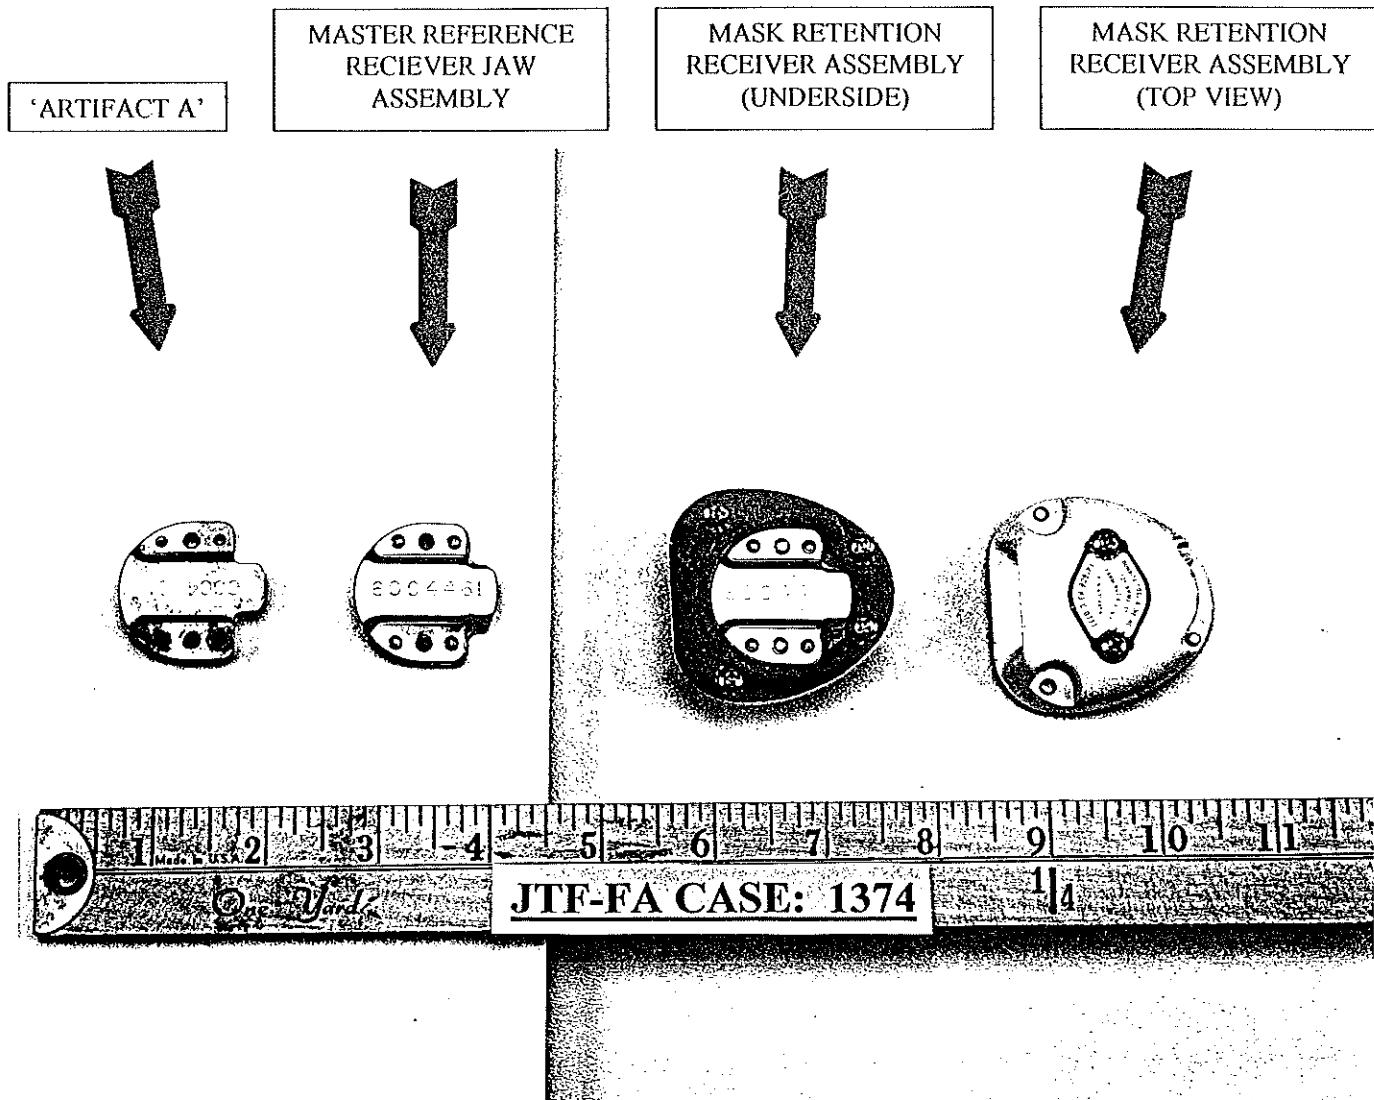
Picture 4 below, depicts a composite view of 'Artifact A' positioned adjacent to various Master Reference Receiver Jaw elements used in the analysis of this artifact.

PICTURE 4. A COMPOSITE VIEW OF 'ARTIFACT A' POSITIONED ADJACENT TO VARIOUS MASTER REFERENCE RECEIVER JAW ELEMENTS.
