EVALUATION OF ARTIFACTS ORIGINATING FROM SOUTH EAST ASIA AIRCRAFT LOSS SITES

SUBJECT: EVALUATION OF LIFE SCIENCES EQUIPMENT ARTIFACTS

ARTIFACT LOT: 1
ARTIFACT TOTAL IN LOT: 465
BATCH IDENTIFICATION: ANALYST ASSIGNED
JTF-FA REFNO CASE NUMBER: 1374
DATE ANALYSIS COMMENCED: 01 AUGUST 2001

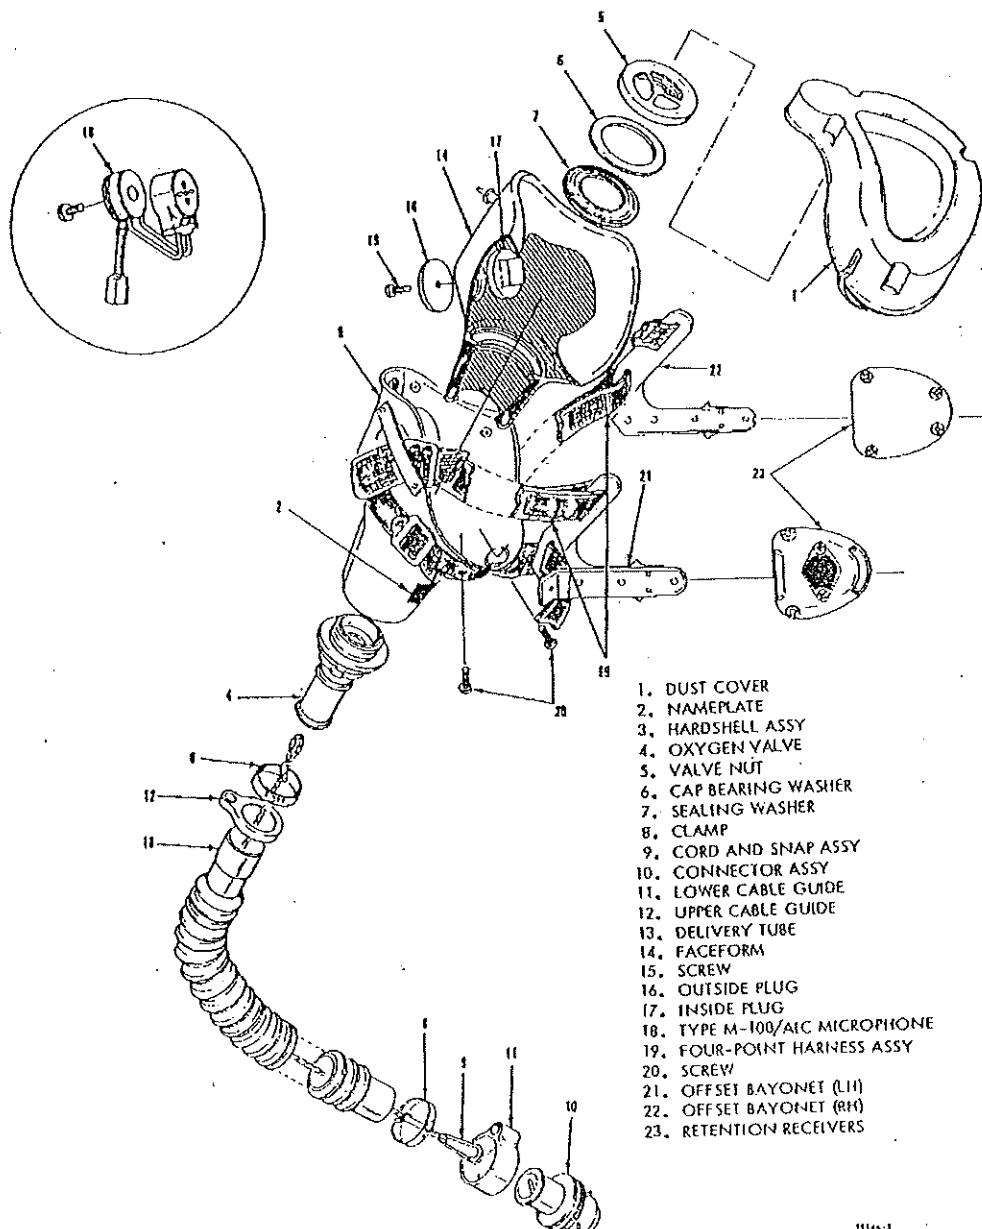
Illustration 1 below, is a drawing of a Type MBU-5/P Oxygen Mask Assembly that depicts the associated Flight Helmet Mounted Retention Receivers (refer to index items number 23) discussed within this section.

ILLUSTRATION 1. A DRAWING OF A TYPE MBU-5/P OXYGEN MASK ASSEMBLY THAT DEPICTS THE ASSOCIATED FLIGHT HELMET MOUNTED RETENTION RECEIVER.

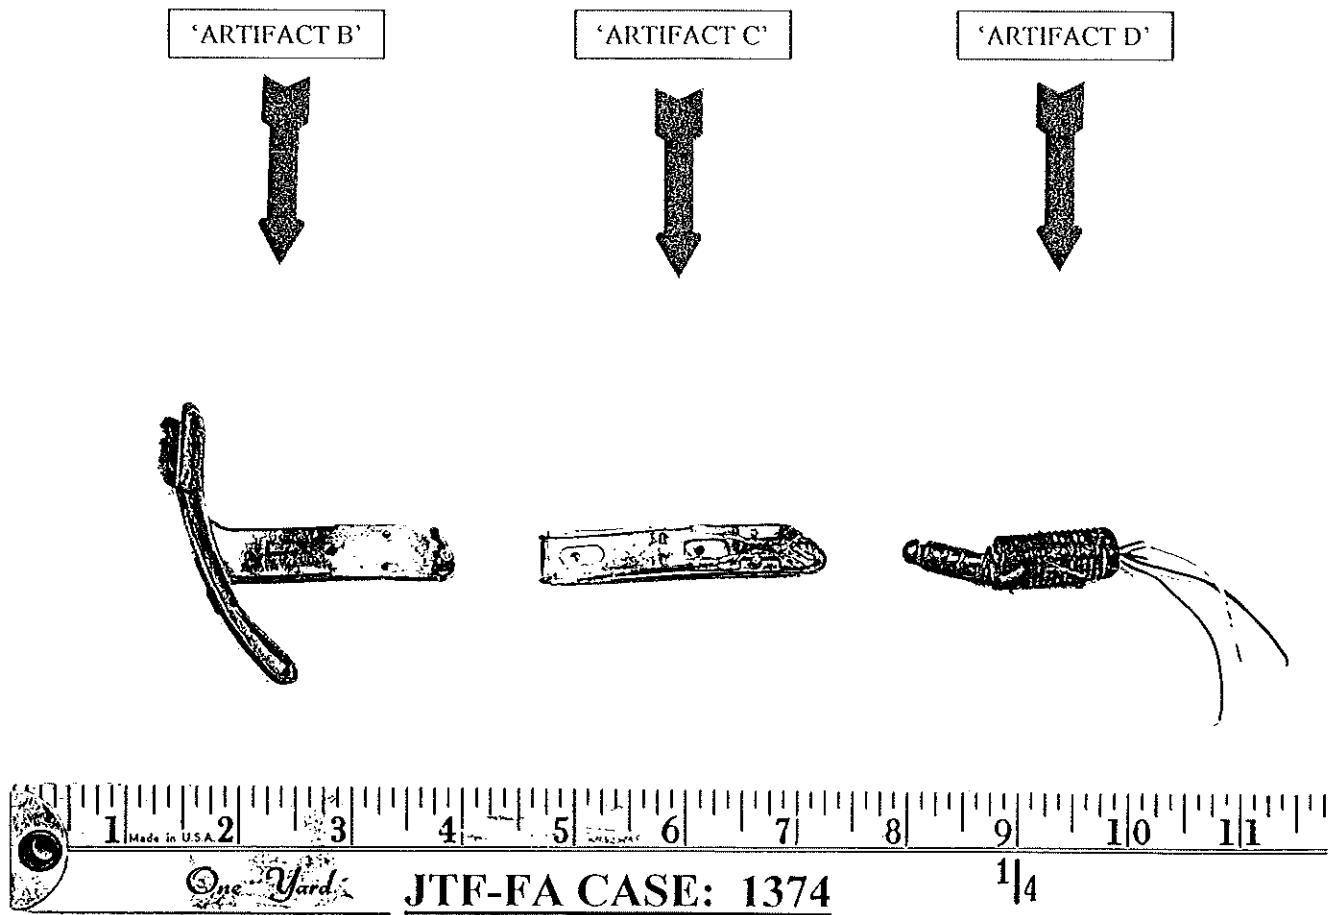
Picture 6 below, depicts three artifacts that have been identified as being comparable to sub-assemblies associated with a U.S. Air Force Type MBU-5/P Oxygen Mask Assembly (hereafter referred to as the 'oxygen mask'). The proper terminologies of these artifacts are:

- ‘Artifact B’, and ‘Artifact C’: Oxygen Mask Retaining Bayonet Fitting, Part Number ‘63D4228’.
- ‘Artifact D’: Communication Cord Jack, Part Number ‘U-174/U’

PICTURE 6. THE ARTIFACTS ATTRIBUTED TO A U.S. AIR FORCE ISSUED TYPE
MBU-5/P OXYGEN MASK ASSEMBLY.

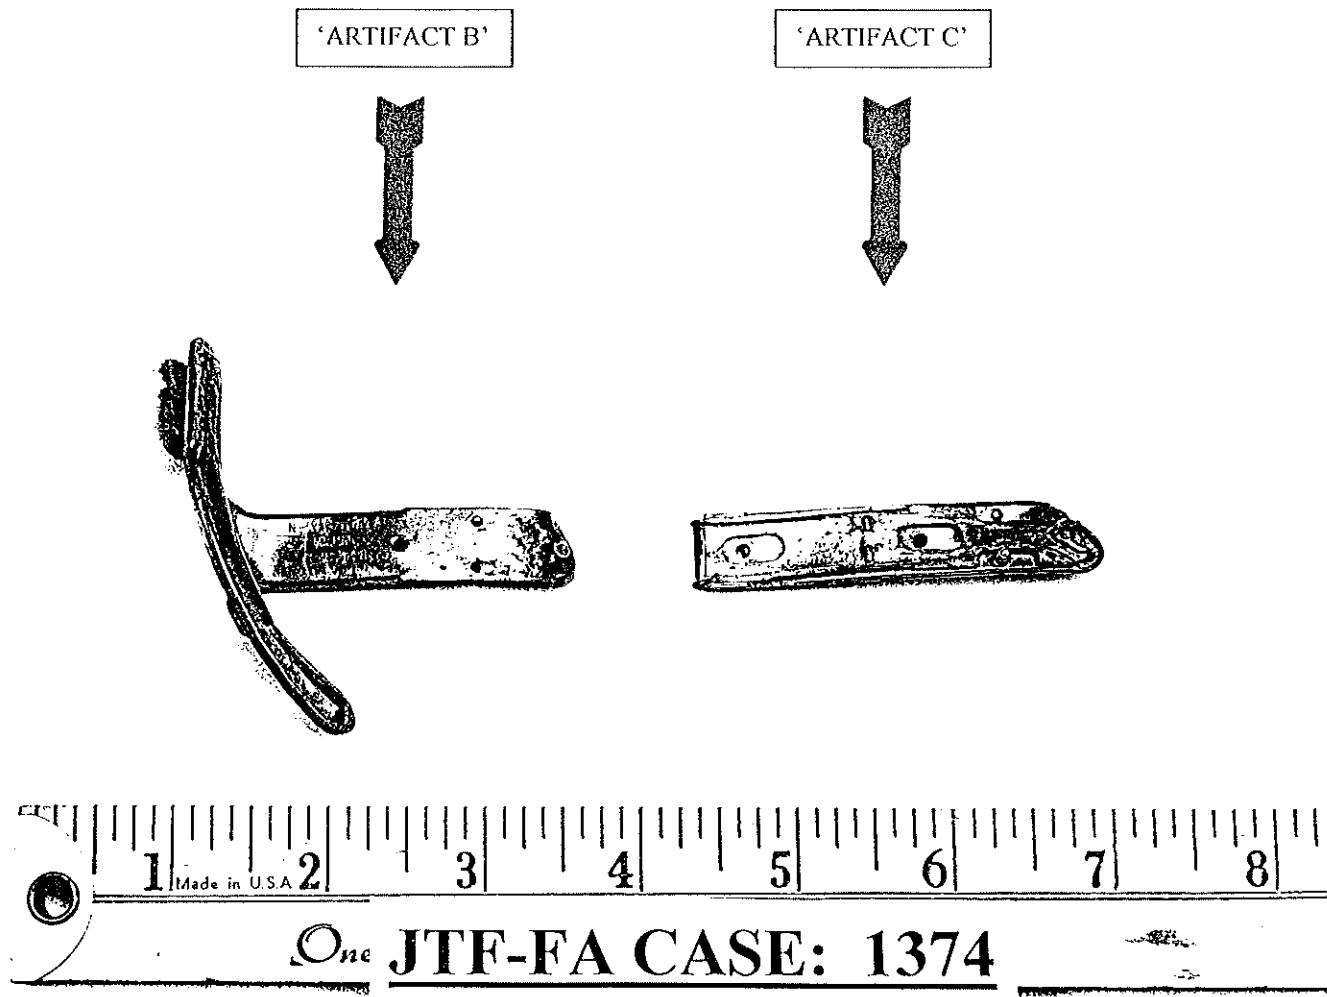
Picture 7 below, depicts an in-line view of two artifacts ('Artifact B', and 'Artifact C') that have been identified as being comparable to the Oxygen Mask Retaining (T-style) Bayonet Fitting (hereafter referred to as the 'bayonet fitting'), an integral component to the oxygen mask assembly. In the assembled state, these two artifacts are co-linked to form a single bayonet fitting.

PICTURE 7. A CLOSE-UP VIEW OF 'ARTIFACT B' AND 'ARTIFACT C'.

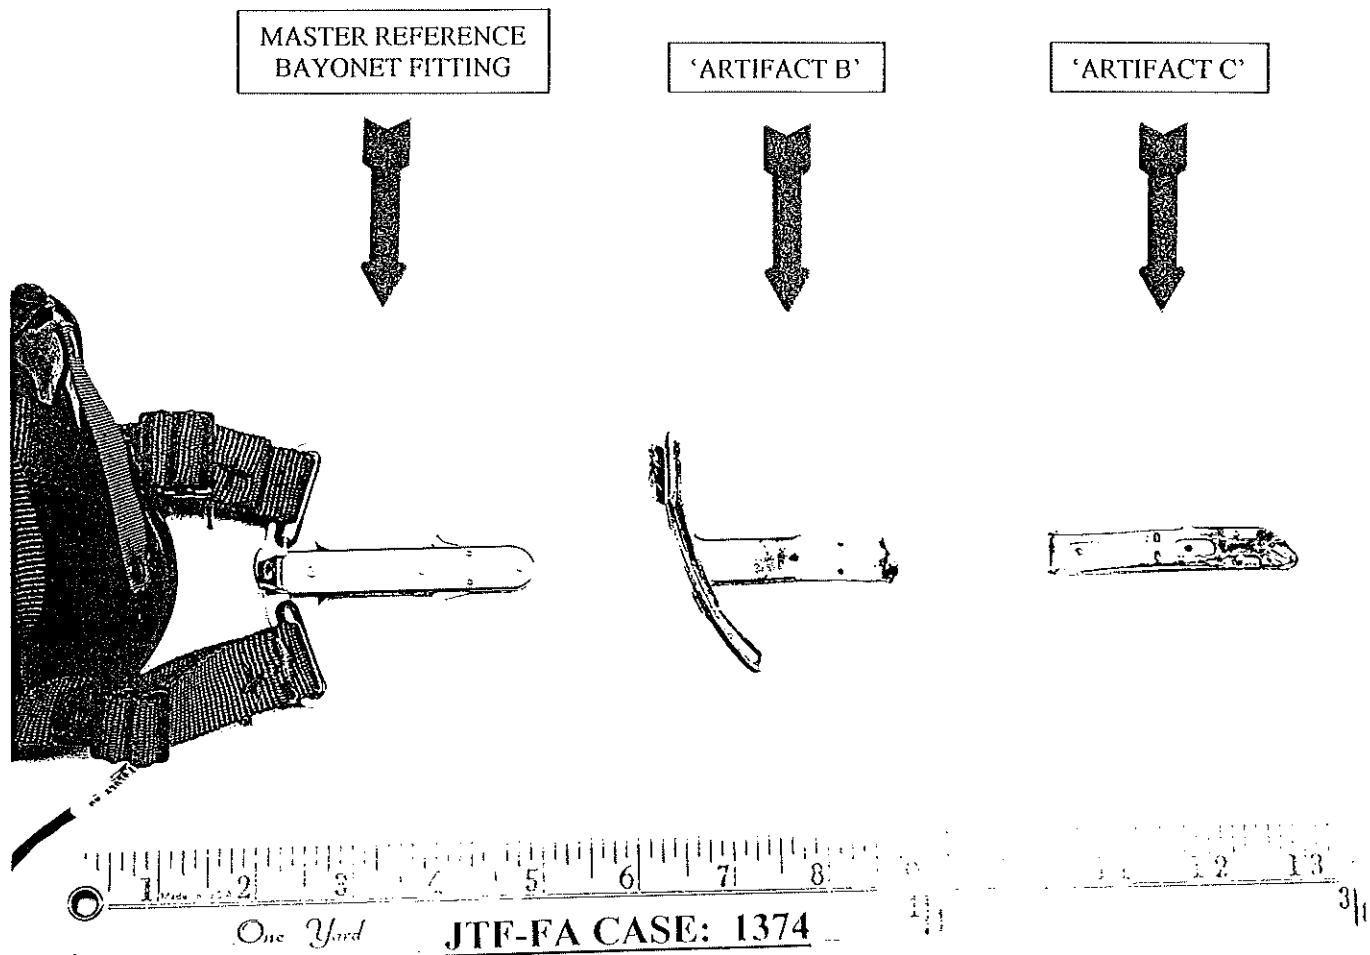
In Picture 8 below, 'Artifact B' and 'Artifact C' are positioned adjacent to a Master Reference (T-style) Bayonet Fitting. As depicted in this picture, all elements are similar in size, and profile. In addition to these physical similarities, both 'Artifact B', and the Master Reference Bayonet Fitting, is permanently stamped with Part Number '63D4228', which positively identifies 'Artifact B and C' as being subcomponents of a time period bayonet fitting.

PICTURE 8. A VIEW OF 'ARTIFACT B' AND 'ARTIFACT C' POSITIONED ADJACENT TO A MASTER REFERENCE (T-STYLE) BAYONET FITTING.

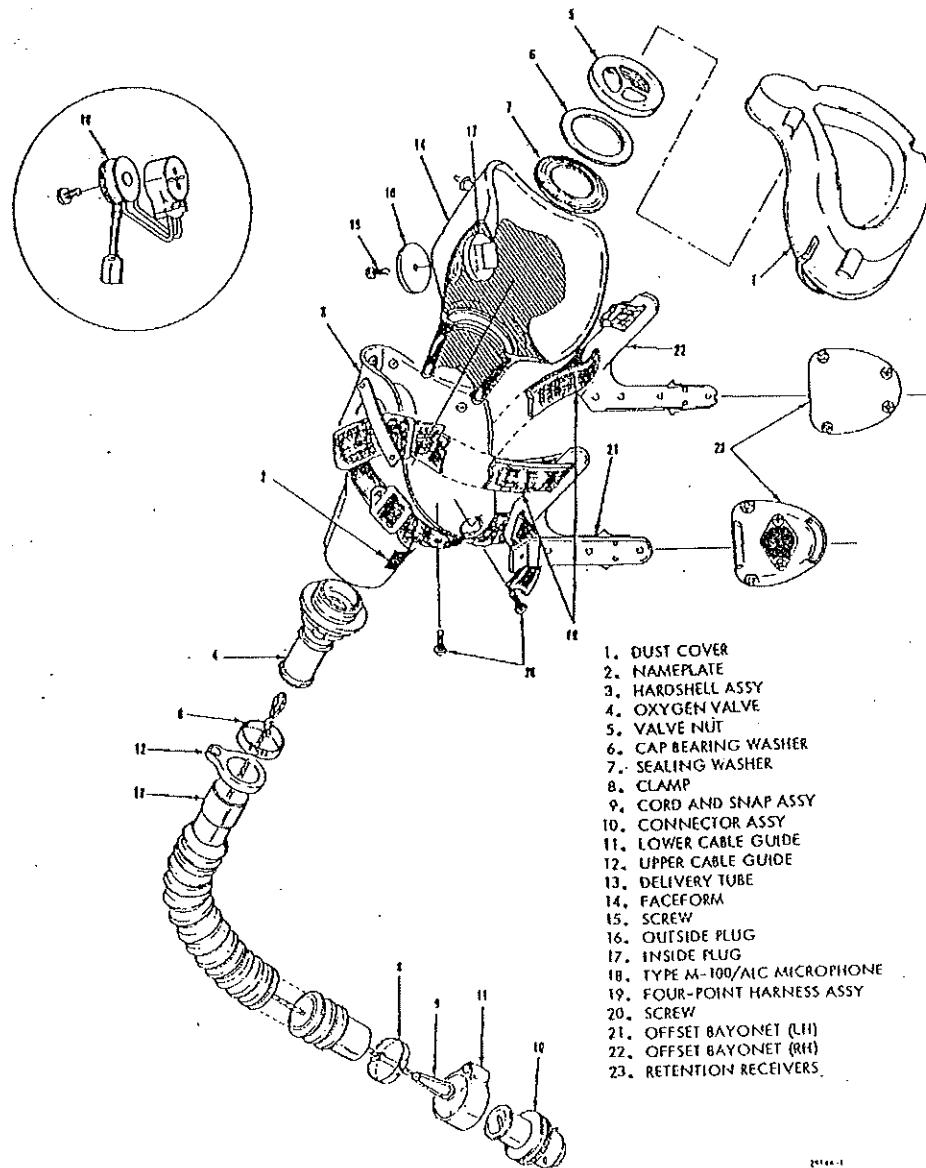
Illustration 2 below, is a drawing of a Type MBU-5/P Oxygen Mask Assembly that depicts the associated Oxygen Mask (Offset Style) Bayonet Fittings (refer to index items number 21 and 22) discussed within this section. (Note: This Illustration depicts an 'offset style' bayonet fitting (current model) that replaced the 'T-style' fitting represented by the artifact.)

ILLUSTRATION 2. A DRAWING OF A TYPE MBU-5/P OXYGEN MASK ASSEMBLY THAT DEPICTS THE ASSOCIATED OXYGEN MASK (OFFSET) BAYONET FITTINGS.

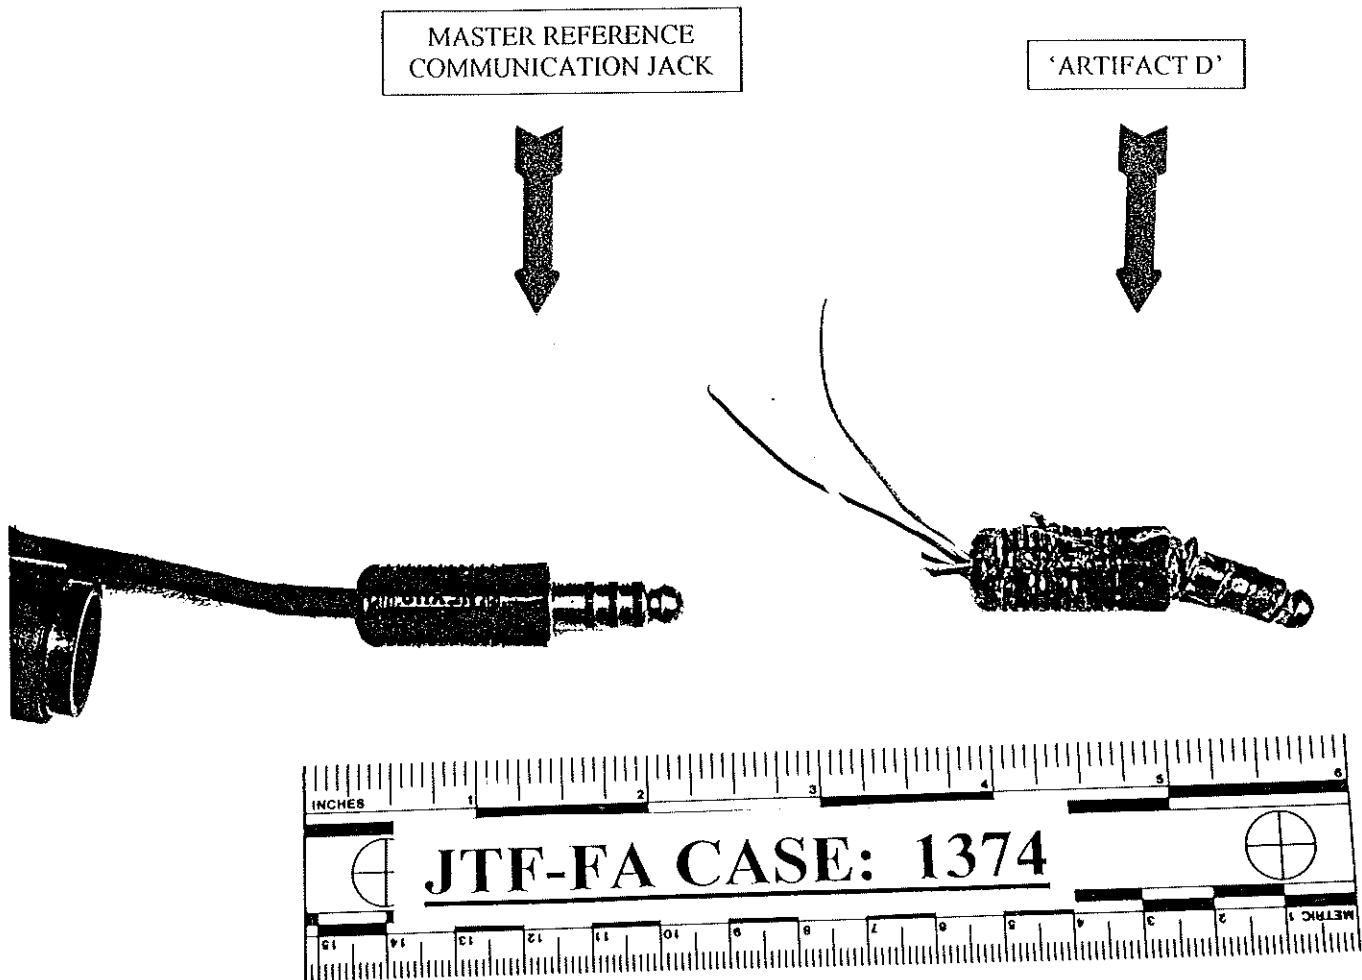
In Picture 11 below, 'Artifact D' is positioned adjacent to a Master Reference Communication Jack. As depicted in this picture, both elements are similar in size, and profile. In addition to these physical similarities, both 'Artifact D', and the Master Reference Communication Jack, are permanently imprinted with Part Number 'U-174/U', which positively identifies 'Artifact D' as being a subcomponent of a time period Communication Cord Assembly.

PICTURE 11. A VIEW OF 'ARTIFACT D' POSITIONED ADJACENT TO A MASTER REFERENCE COMMUNICATION JACK.

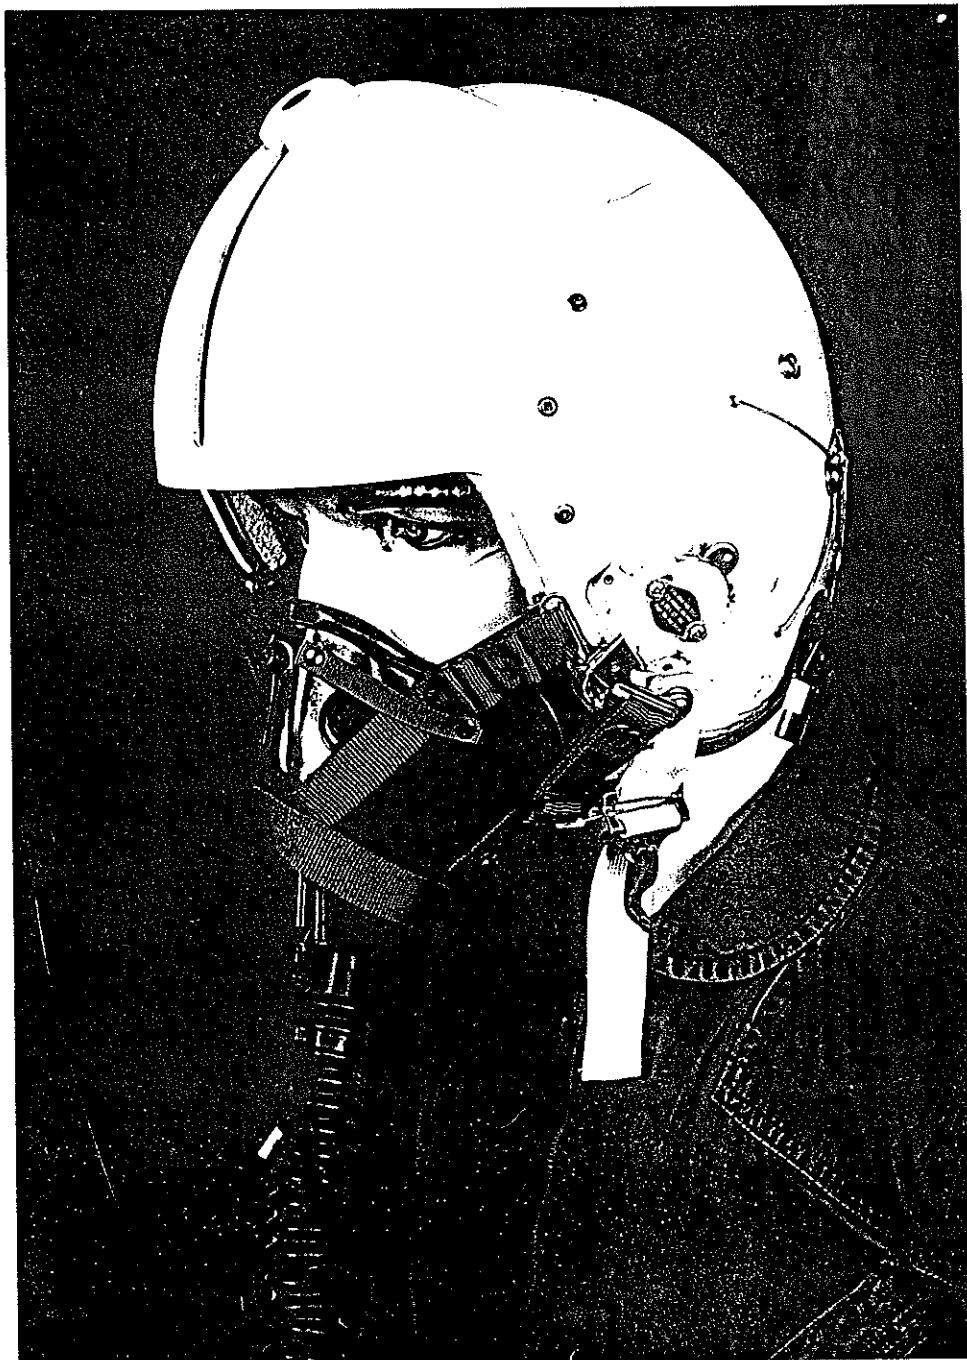
PICTURE 13. AN OVERALL SIDE VIEW OF THE MASTER REFERENCE TYPE
MBU-5/P OXYGEN MASK, AND THE TYPE HGU-2A/P FLIGHT HELMET
USED IN THE ANALYSIS OF THIS REPORT.

Picture 13 below, is an overall side view of the Master Reference Type MBU-5/P Oxygen Mask Assembly, and the Type HGU-2A/P Flight Helmet Assembly used in this section. In this Picture, the oxygen mask is secured to the flight helmet retention receivers by means of the (T-style) bayonet fitting.

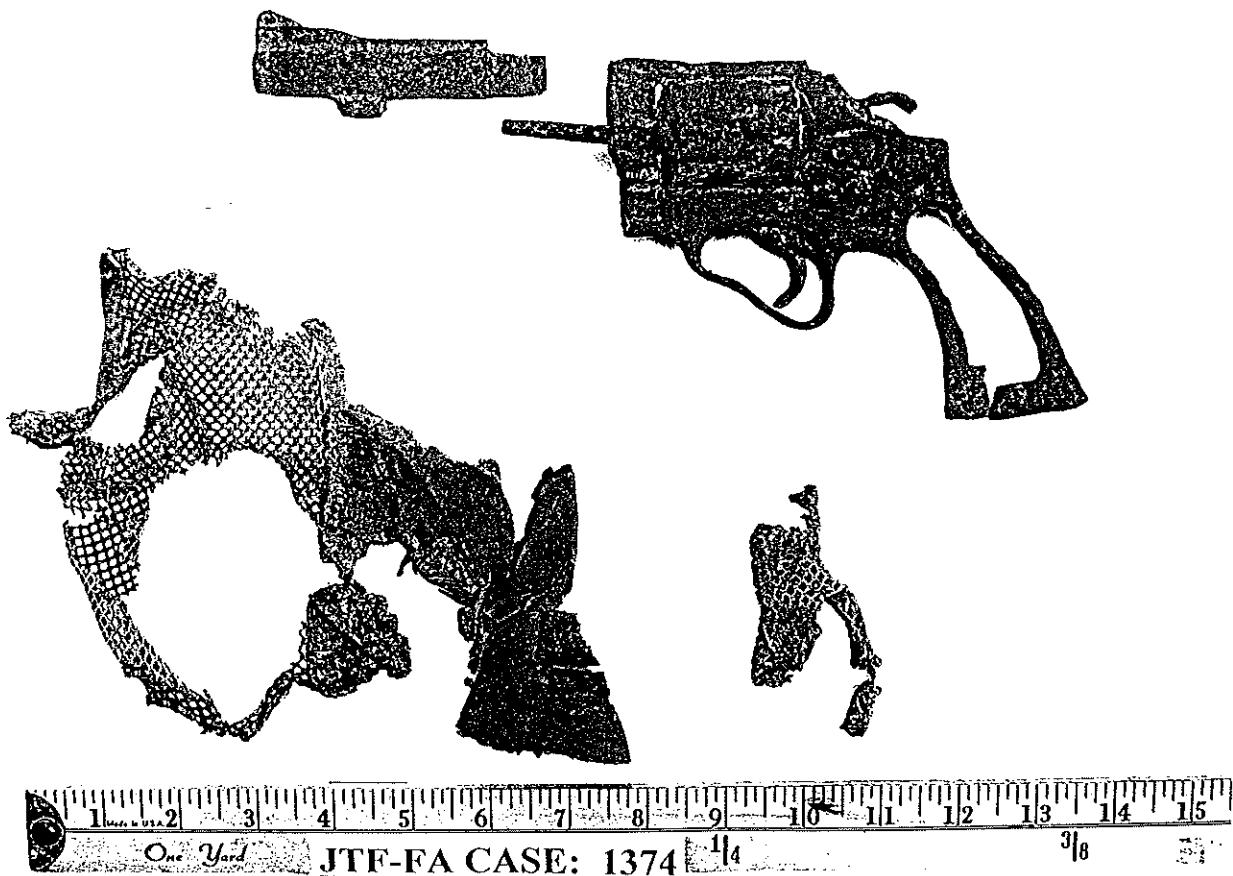
PICTURE 1. THE SURVIVAL VEST AND .38 CALIBER REVOLVER ARTIFACTS.

Four artifacts submitted for analysis (Picture 1 below) were provisionally identified as being comparable to a U.S. Air Force Survival Vest, and a .38 Caliber Service Revolver. Each element will be discussed in more detail in the following sub-sections of this report:

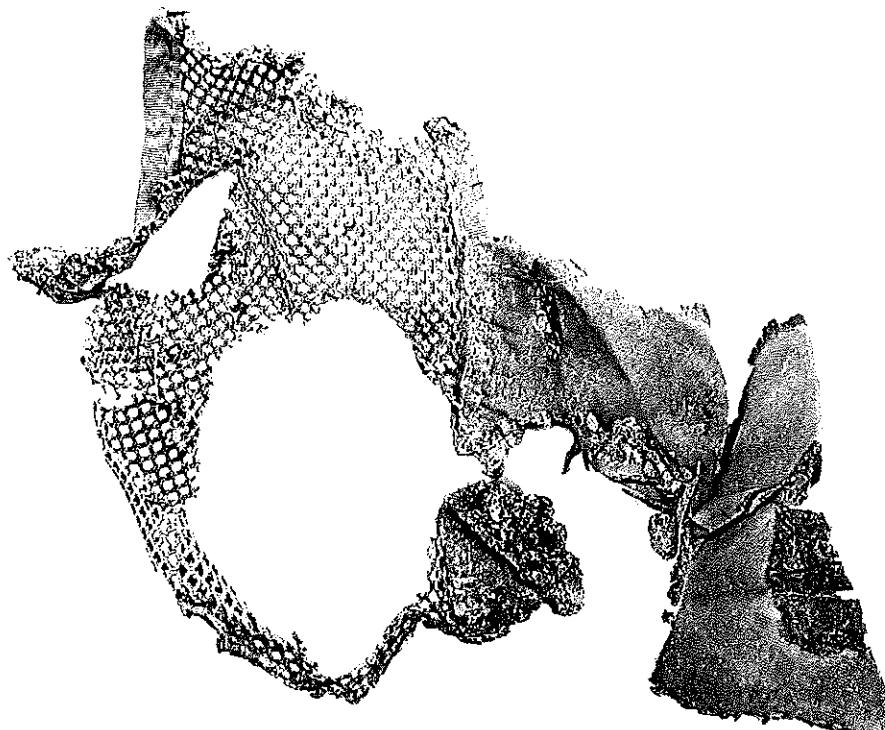
PICTURE 2. A VIEW OF 'ARTIFACT A' WHICH IS ATTRIBUTED TO THE SURVIVAL VEST.

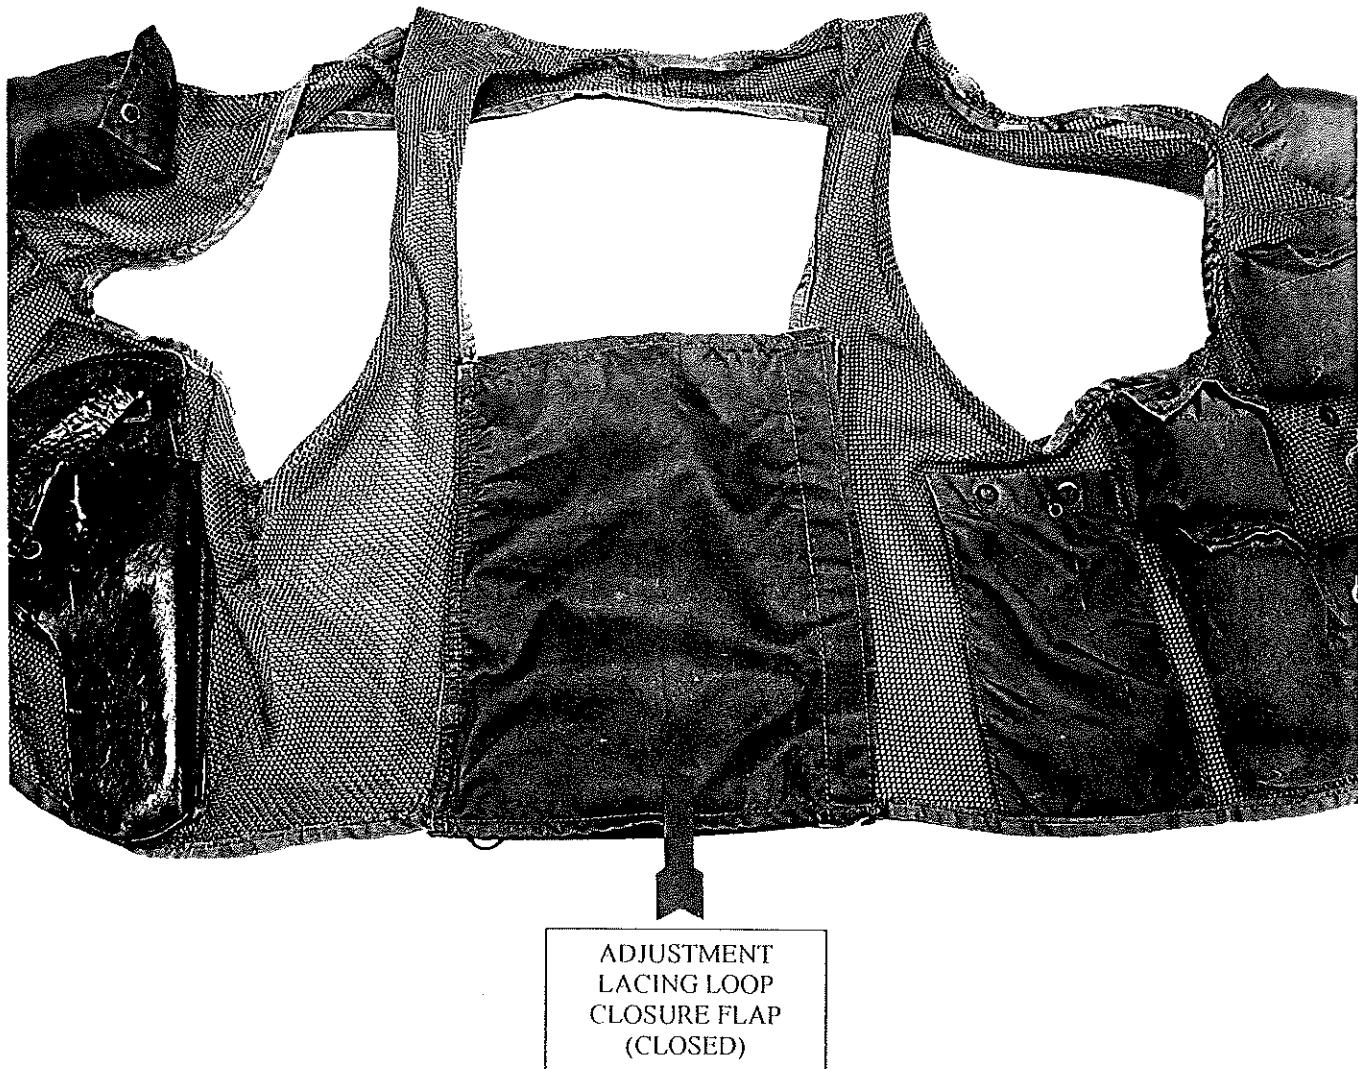
PICTURE 3. A VIEW OF THE BACK REGION OF THE MASTER REFERENCE SURVIVAL VEST WITH THE 'ADJUSTMENT LACING LOOP CLOSURE FLAP' CLOSED (CONCEALING THE ADJUSTMENT CORD AND LACING LOOPS).

Picture 3 below, depicts a full view of the self adjustment fitting segment in the back region of a Master Reference Survival Vest. In this picture, the 'adjustment lacing loop closure flap' is closed (concealing the adjustment cord and lacing loops) and secured by matching Velcro tapes. (Refer to Picture 5, Page 4-5 for a view of this region with the 'closure flap' open, revealing the adjustment cord and lacing loops.)

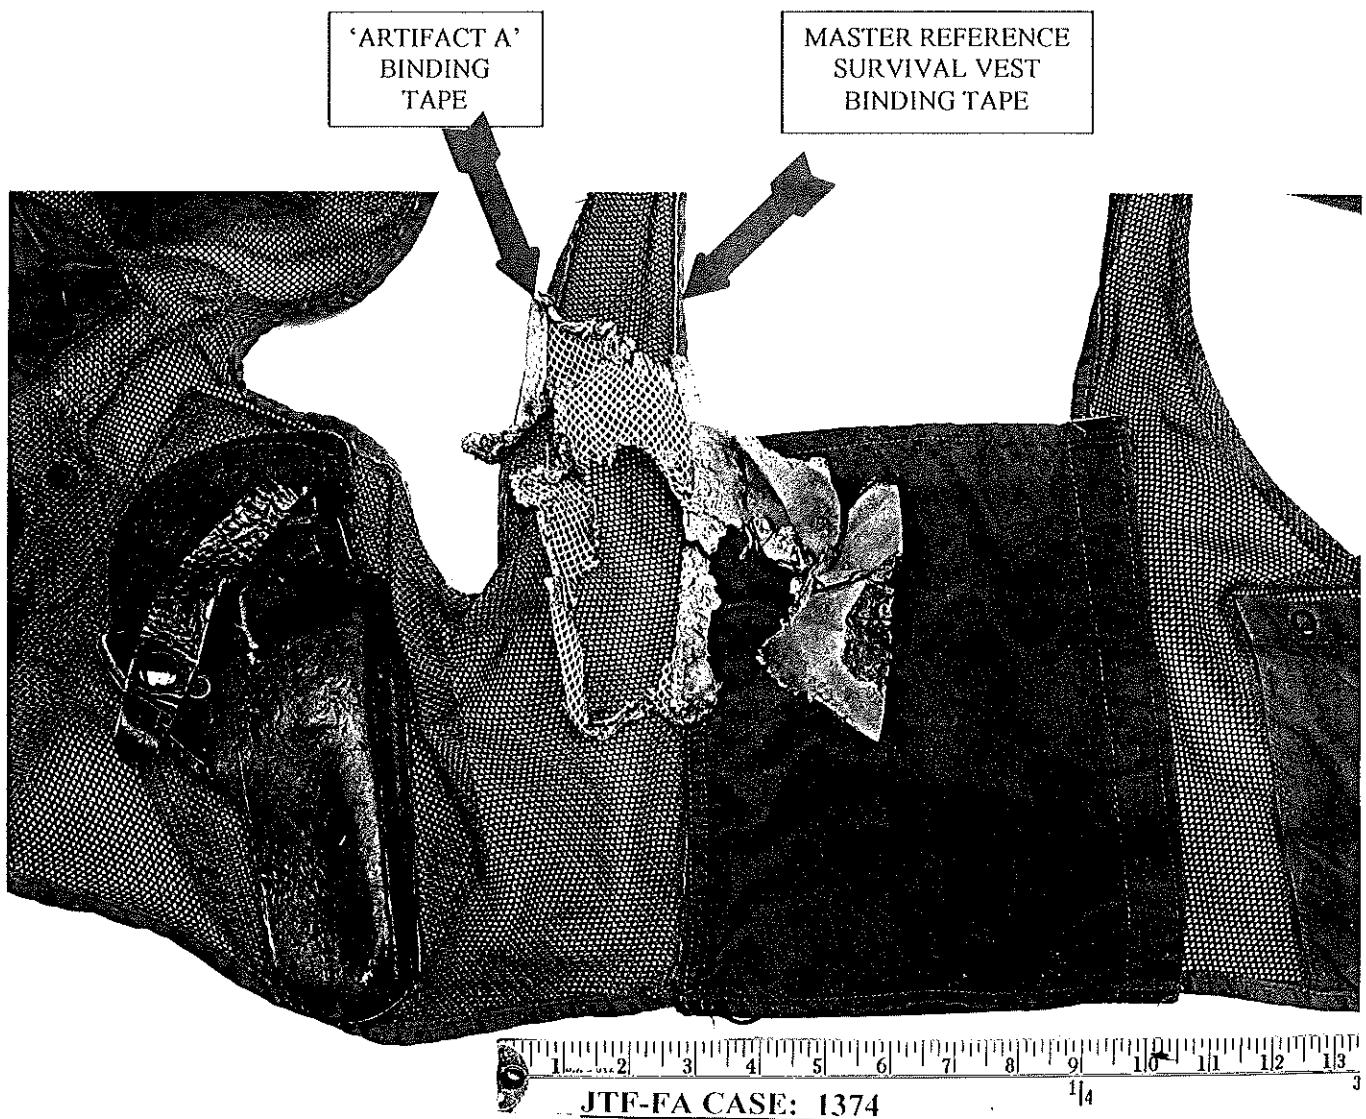
PICTURE 4. A VIEW DISPLAYING THE PRESENCE OF BINDING TAPE ON 'ARTIFACT A' AS WELL AS ON THE MASTER REFERENCE SURVIVAL VEST.

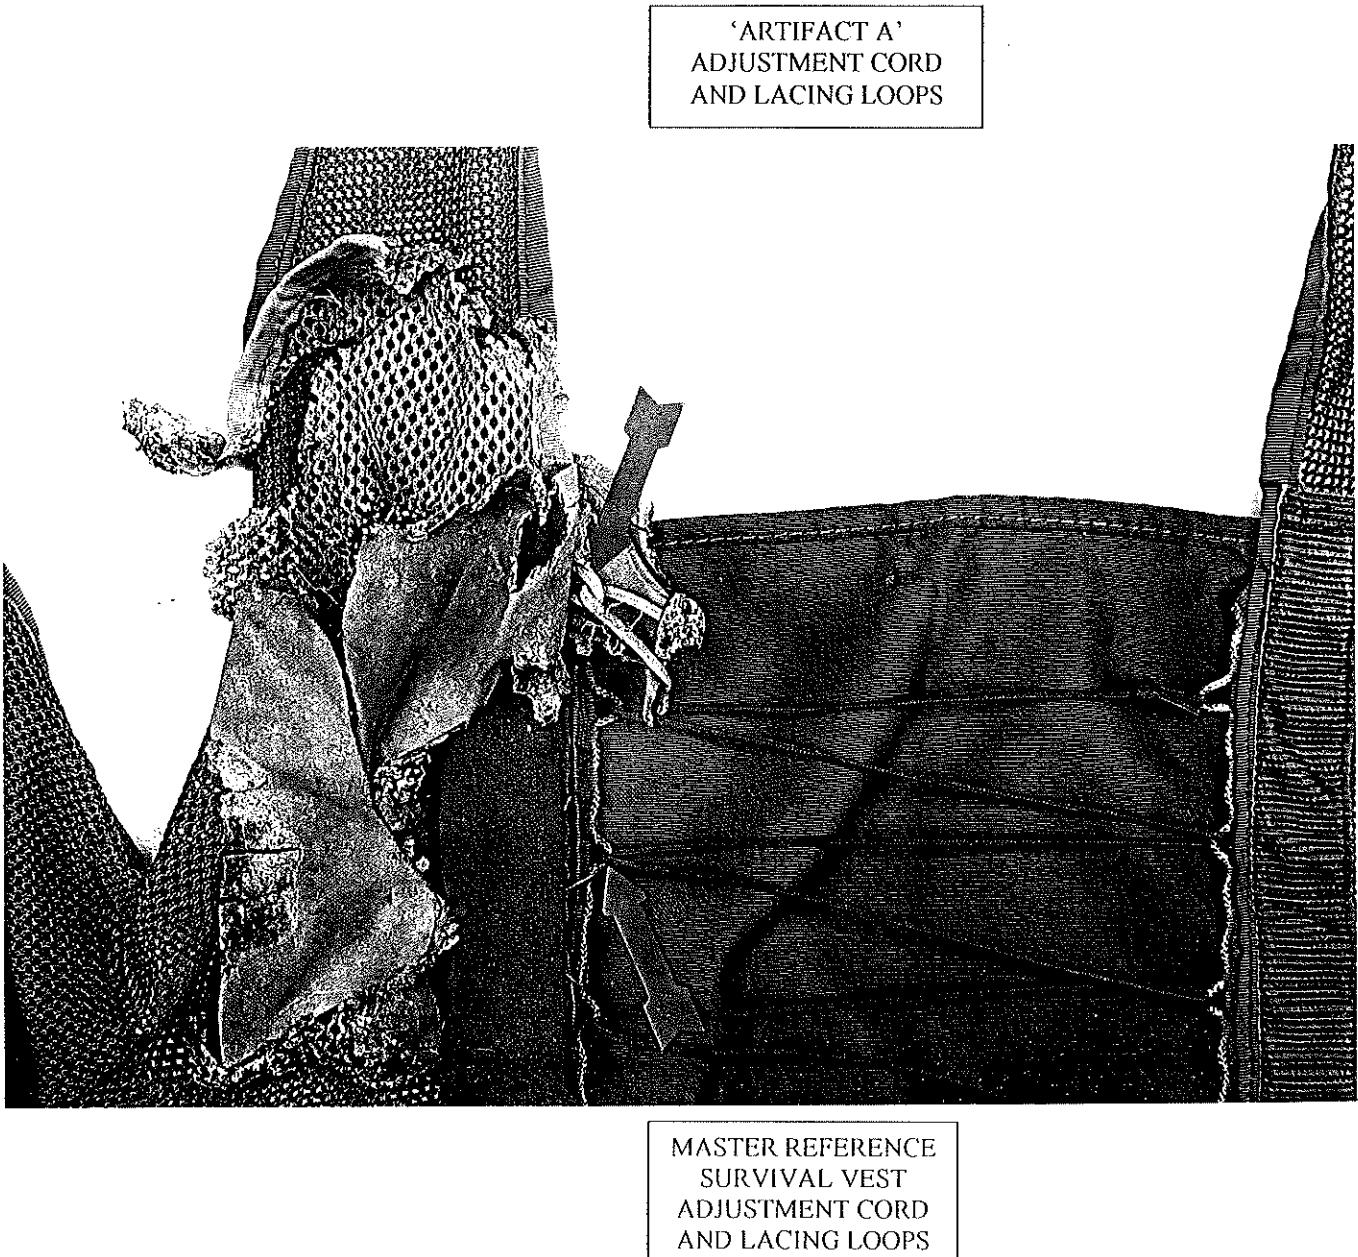
PICTURE 6. A VIEW DISPLAYING THE PRESENCE OF ADJUSTMENT CORD
AND LACING LOOPS ON 'ARTIFACT A', AS WELL AS ON THE MASTER
REFERENCE SURVIVAL VEST.

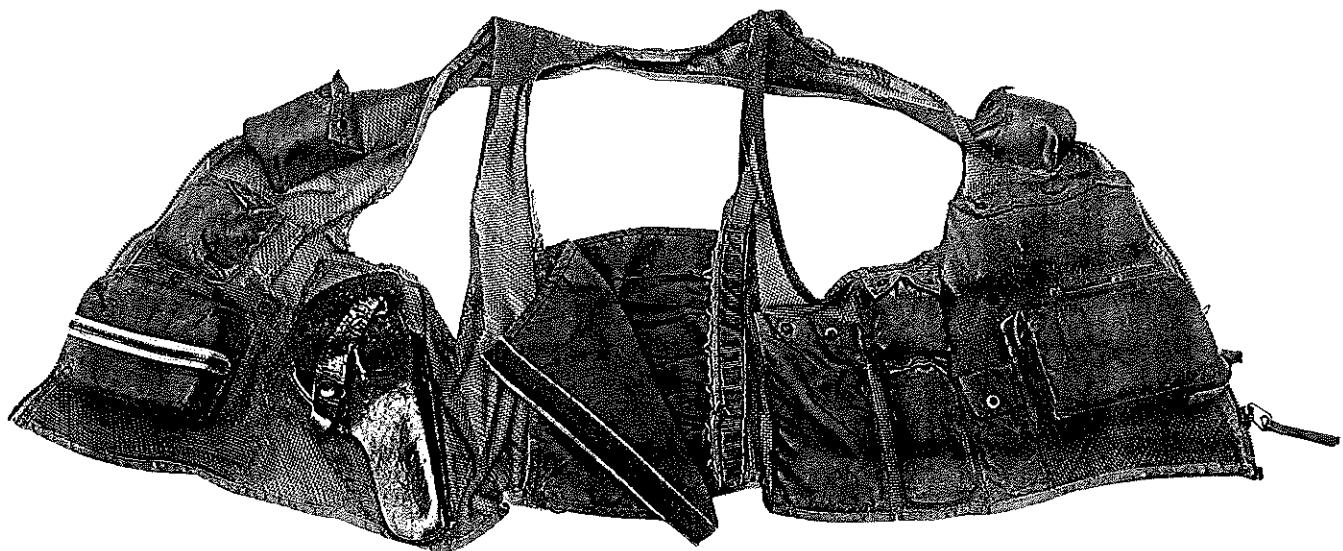
PICTURE 7. A VIEW OF THE TYPE SRU-21/P MASTER REFERENCE SURVIVAL VEST.

Picture 7 below, displays the Type SRU-21/P Master Reference Survival Vest that was used in the analysis of the artifacts for this section.

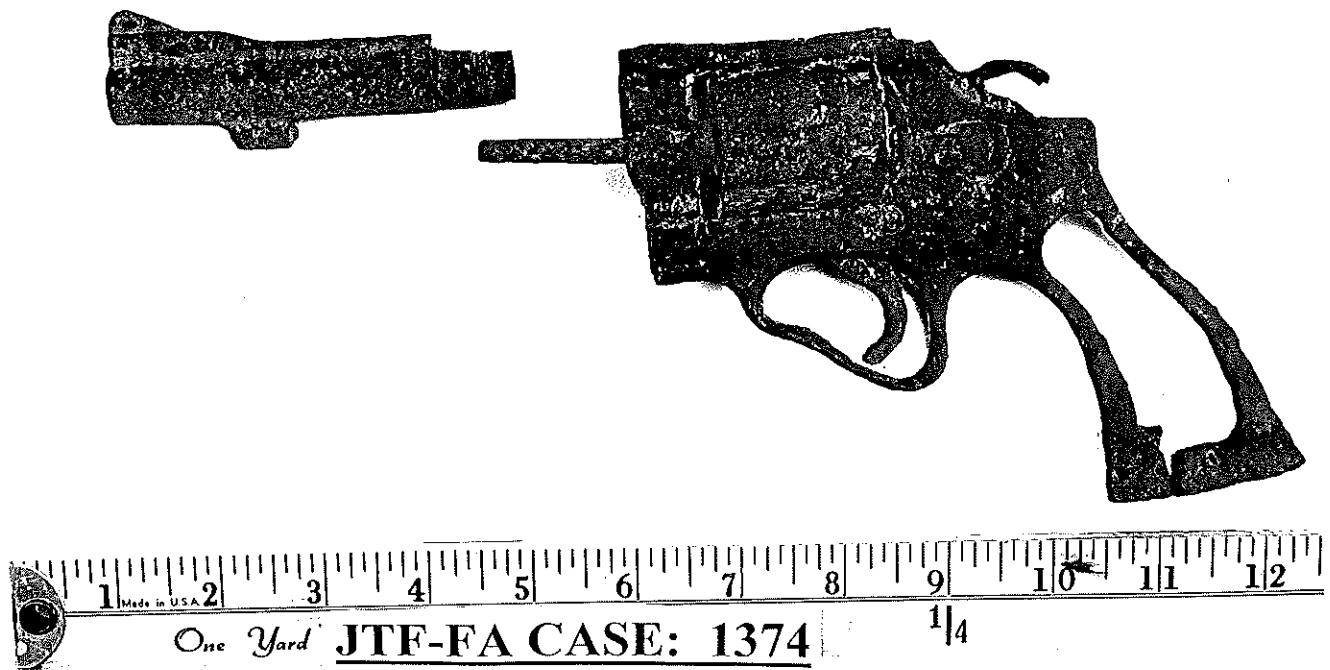
PICTURE 8. A CLOSE-UP VIEW OF THE TWO .38 CALIBER REVOLVER ARTIFACTS.

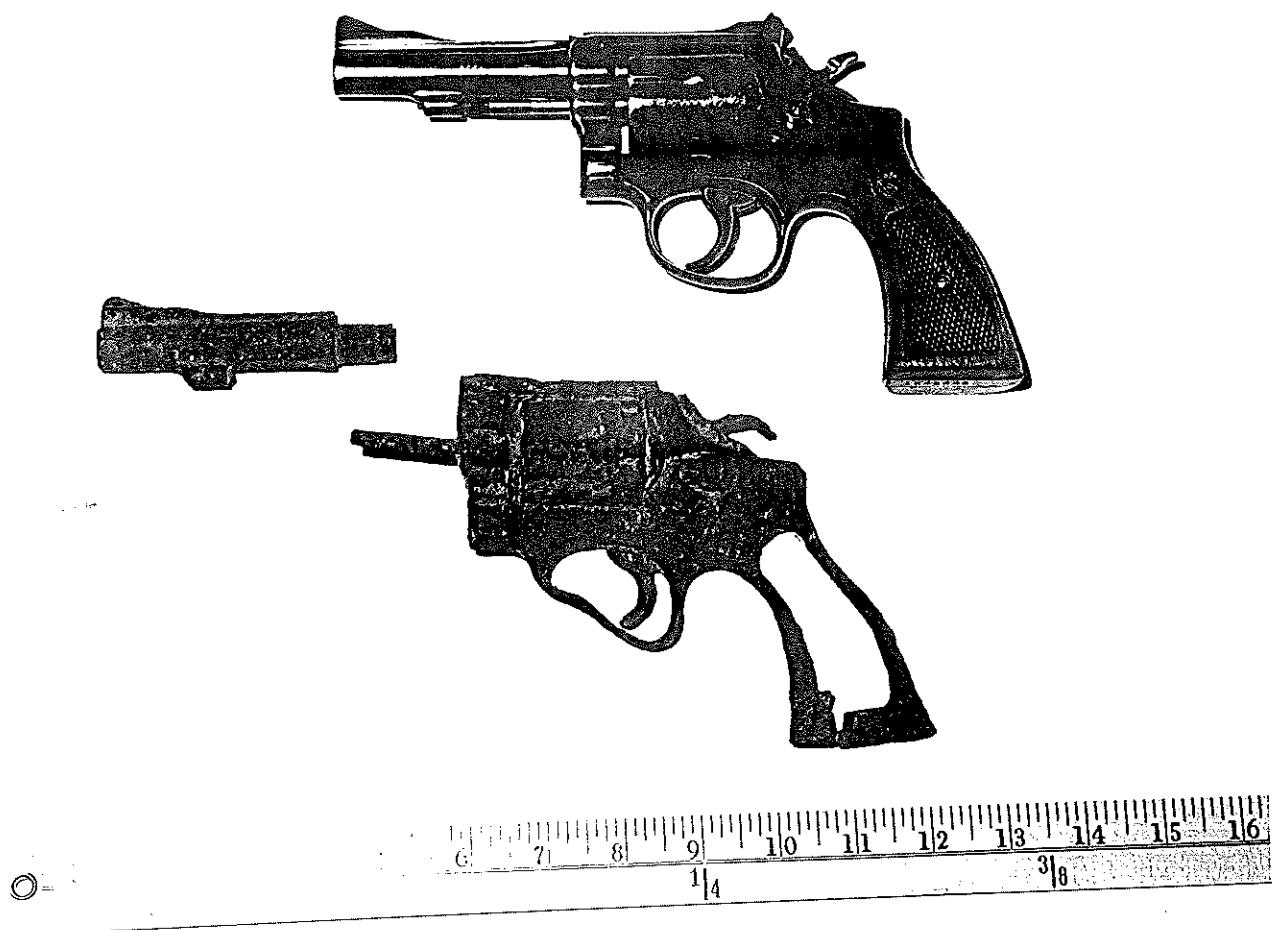
PICTURE 9. A VIEW OF THE .38 CALIBER REVOLVER ARTIFACTS
POSITIONED ADJACENT TO THE MASTER REFERENCE
.38 CALIBER REVOLVER.

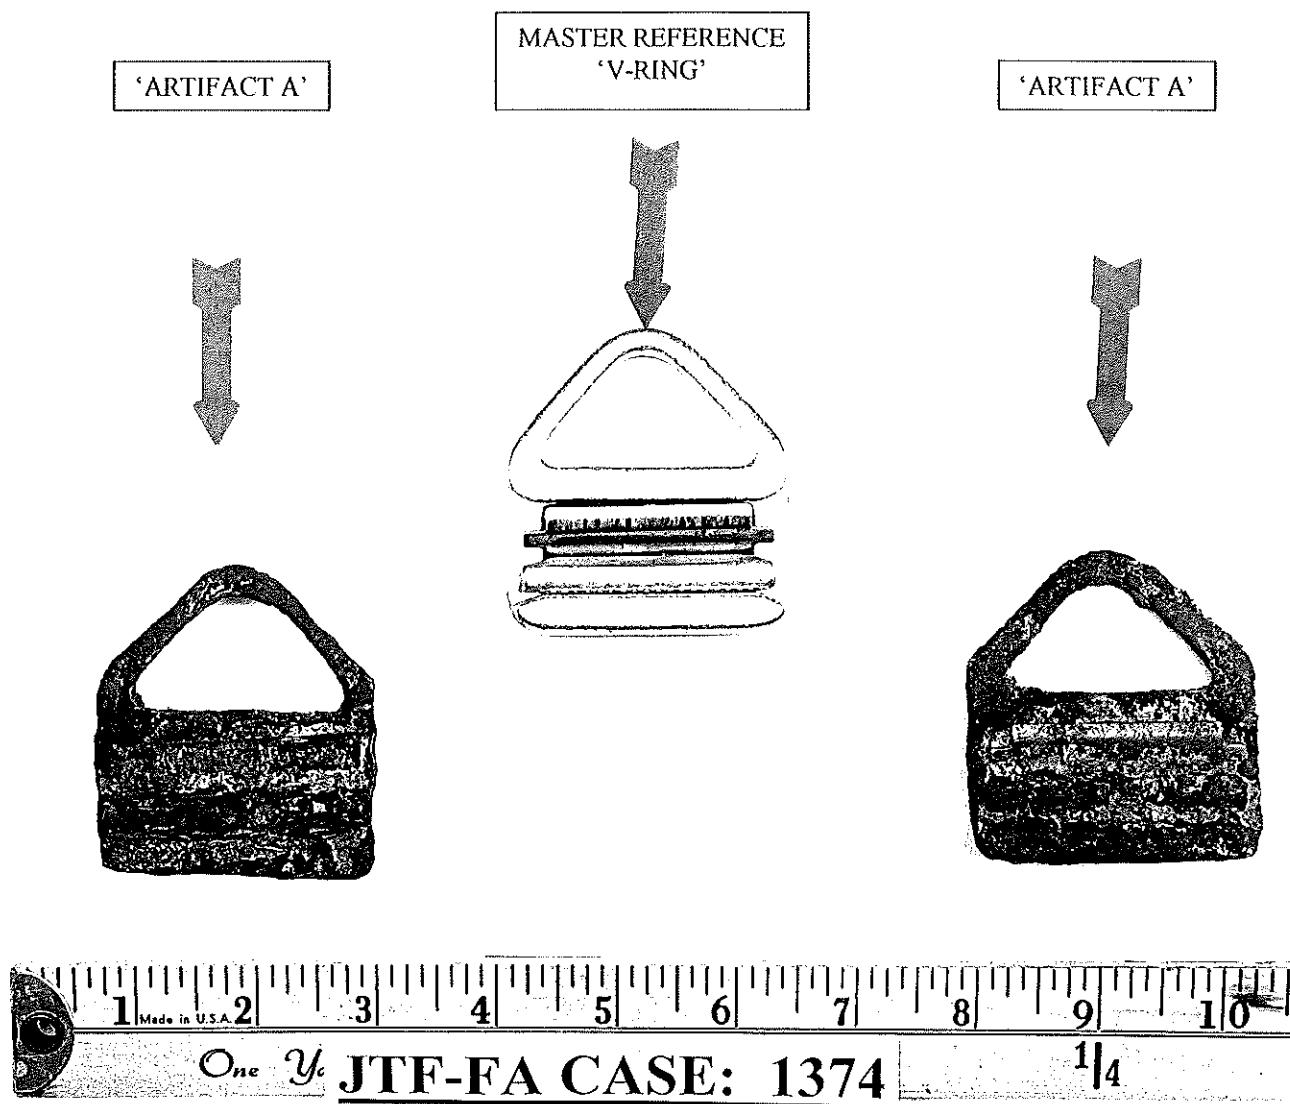
PICTURE 2. A VIEW OF THE TWO ARTIFACTS ('ARTIFACT A') POSITIONED ADJACENT TO A MASTER REFERENCE V-RING.

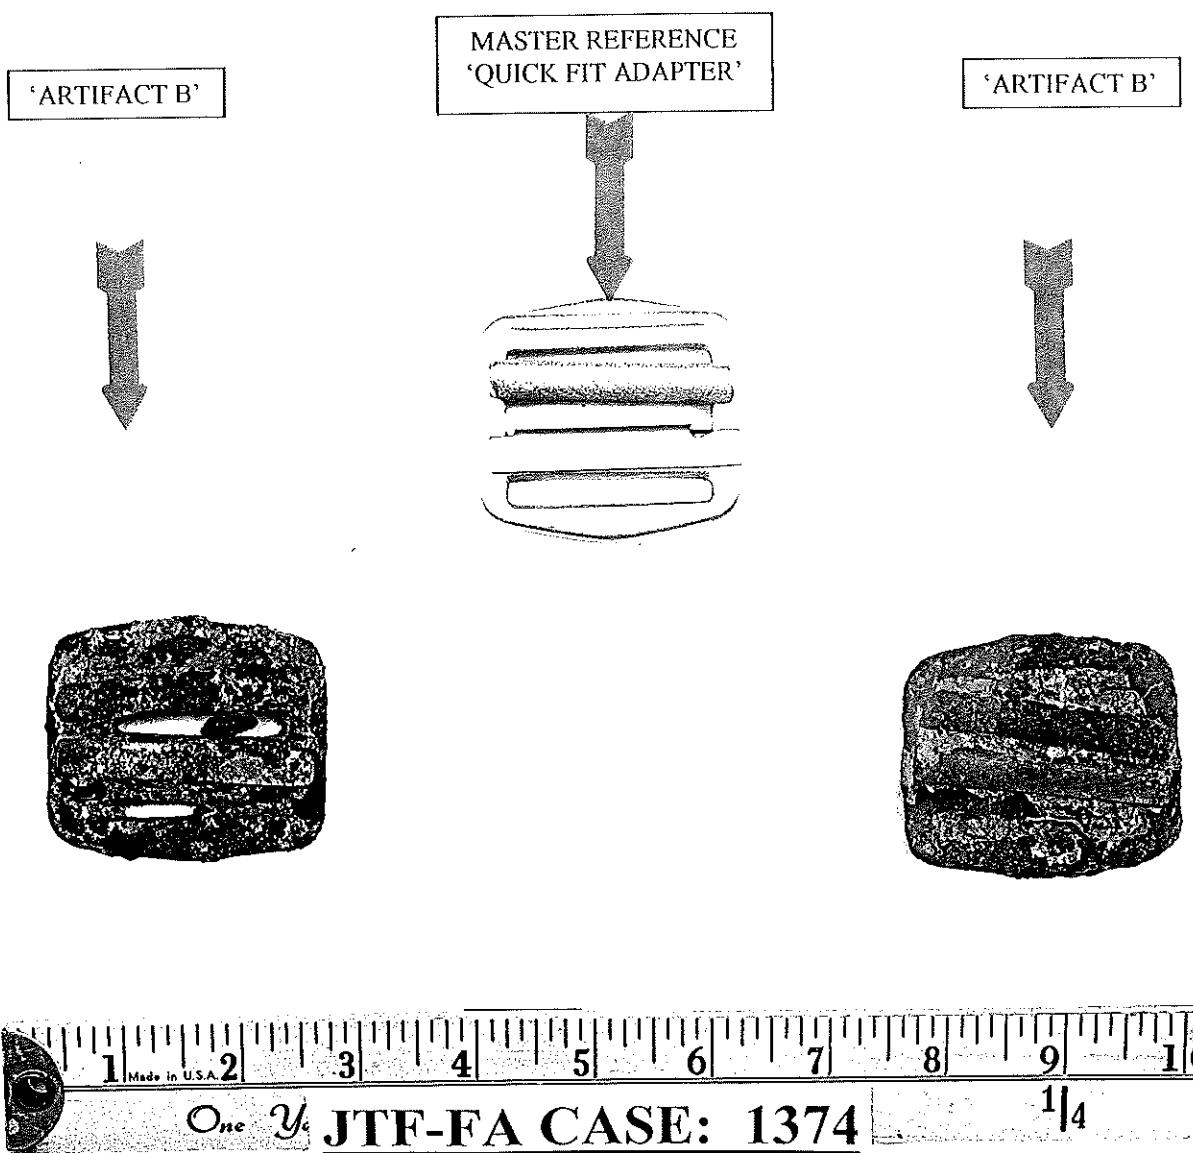
PICTURE 3. A VIEW OF THE TWO ARTIFACTS ('ARTIFACT B') POSITIONED ADJACENT TO A MASTER REFERENCE QUICK FIT ADAPTER.
