EVALUATION OF ARTIFACTS ORIGINATING FROM SOUTH EAST ASIA AIRCRAFT LOSS SITES

SUBJECT: EVALUATION OF LIFE SCIENCES EQUIPMENT ARTIFACTS

ARTIFACT LOT: 1
ARTIFACT TOTAL IN LOT: 465
BATCH IDENTIFICATION: ANALYST ASSIGNED
JTF-FA REFNO CASE NUMBER: 1374
DATE ANALYSIS COMMENCED: 01 AUGUST 2001

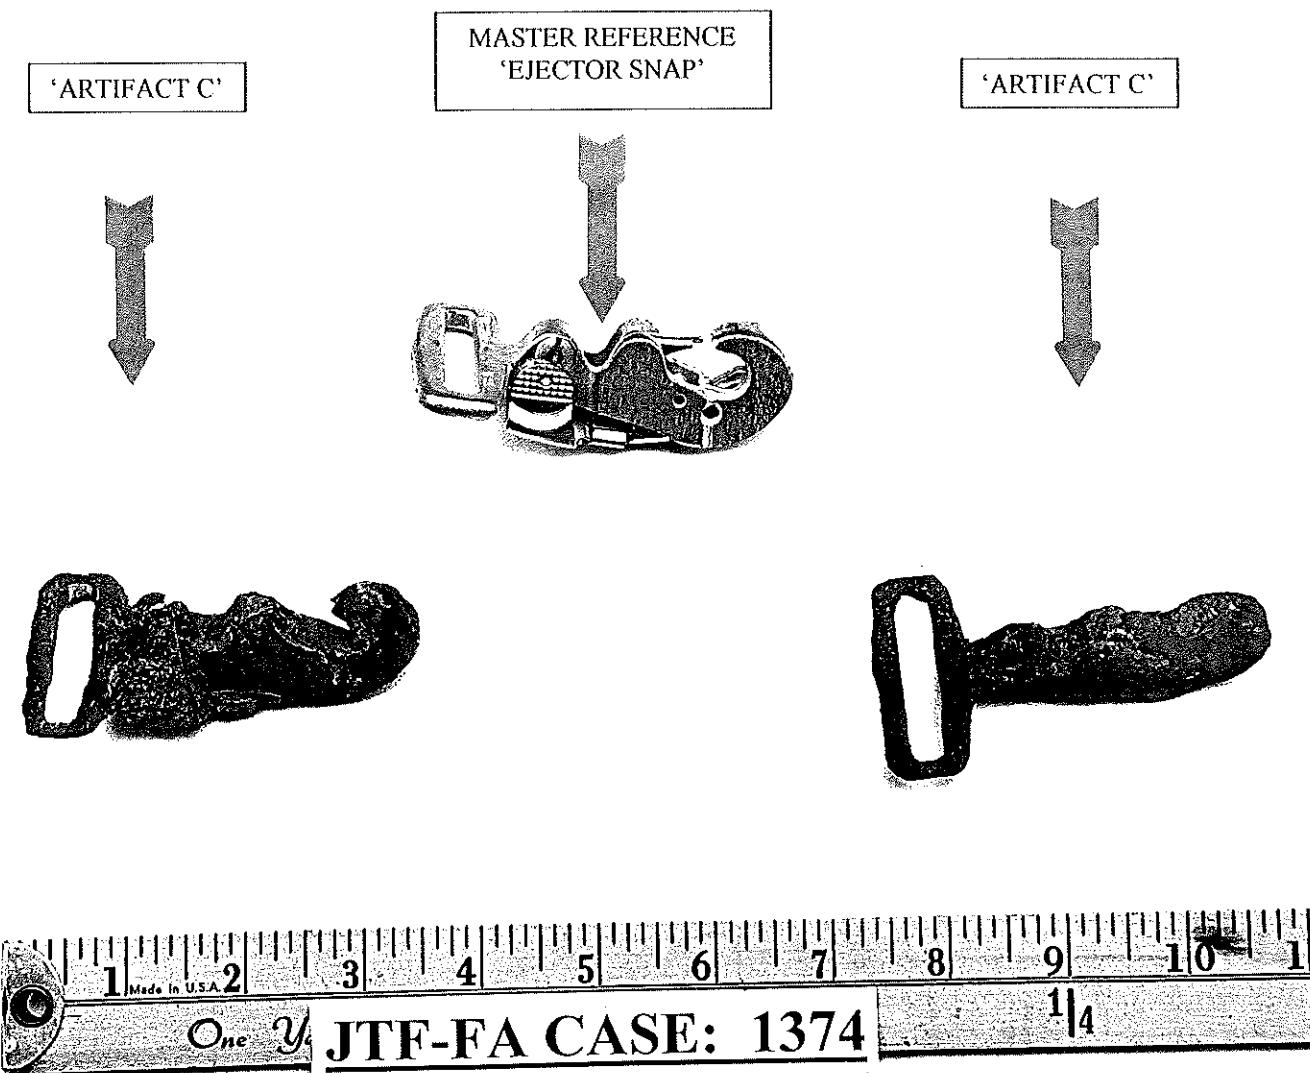
PICTURE 4. A VIEW OF THE TWO ARTIFACTS ('ARTIFACT C') POSITIONED ADJACENT TO A MASTER REFERENCE EJECTOR SNAP.

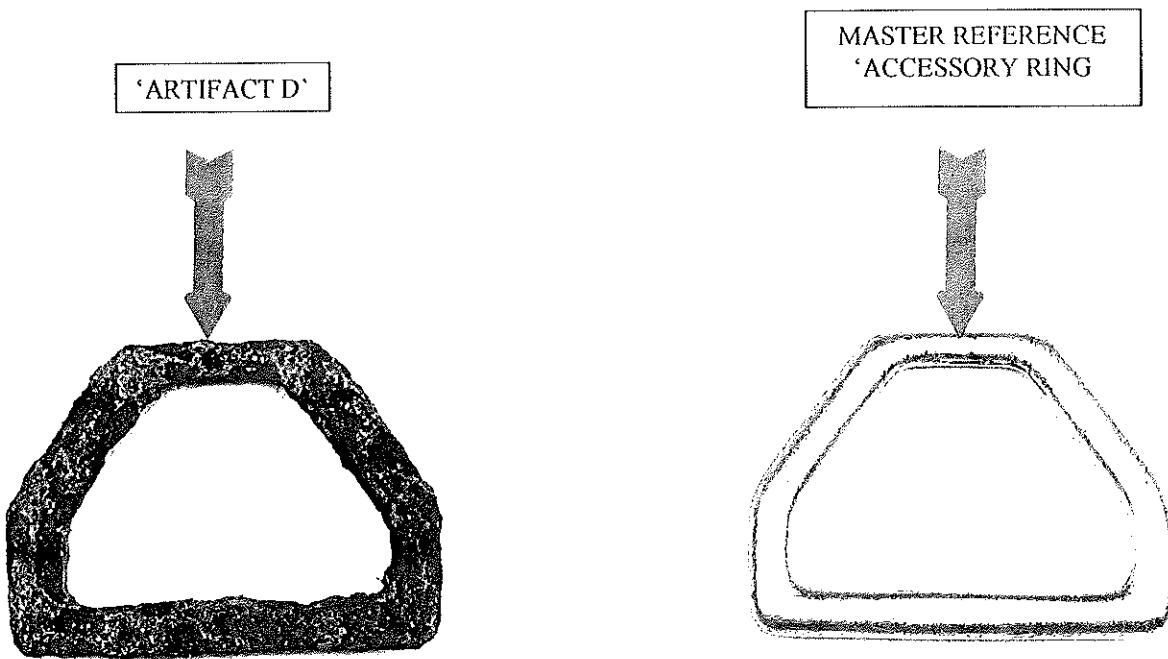
PICTURE 5. A VIEW OF 'ARTIFACT D' POSITIONED ADJACENT TO A MASTER REFERENCE ACCESSORY RING.

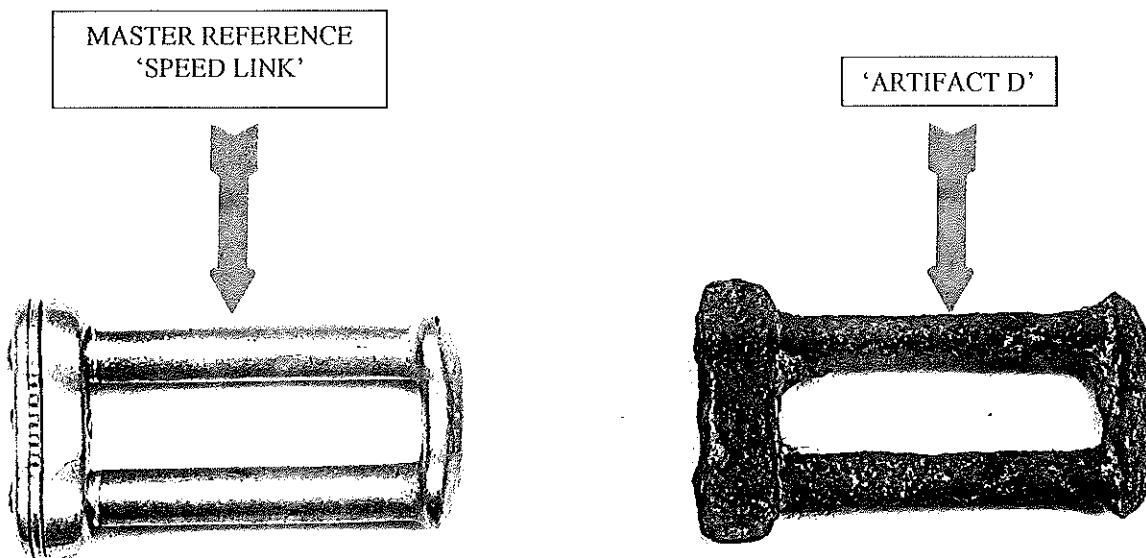
PICTURE 6. A VIEW OF 'ARTIFACT E' POSITIONED ADJACENT TO A MASTER REFERENCE SPEED LINK.

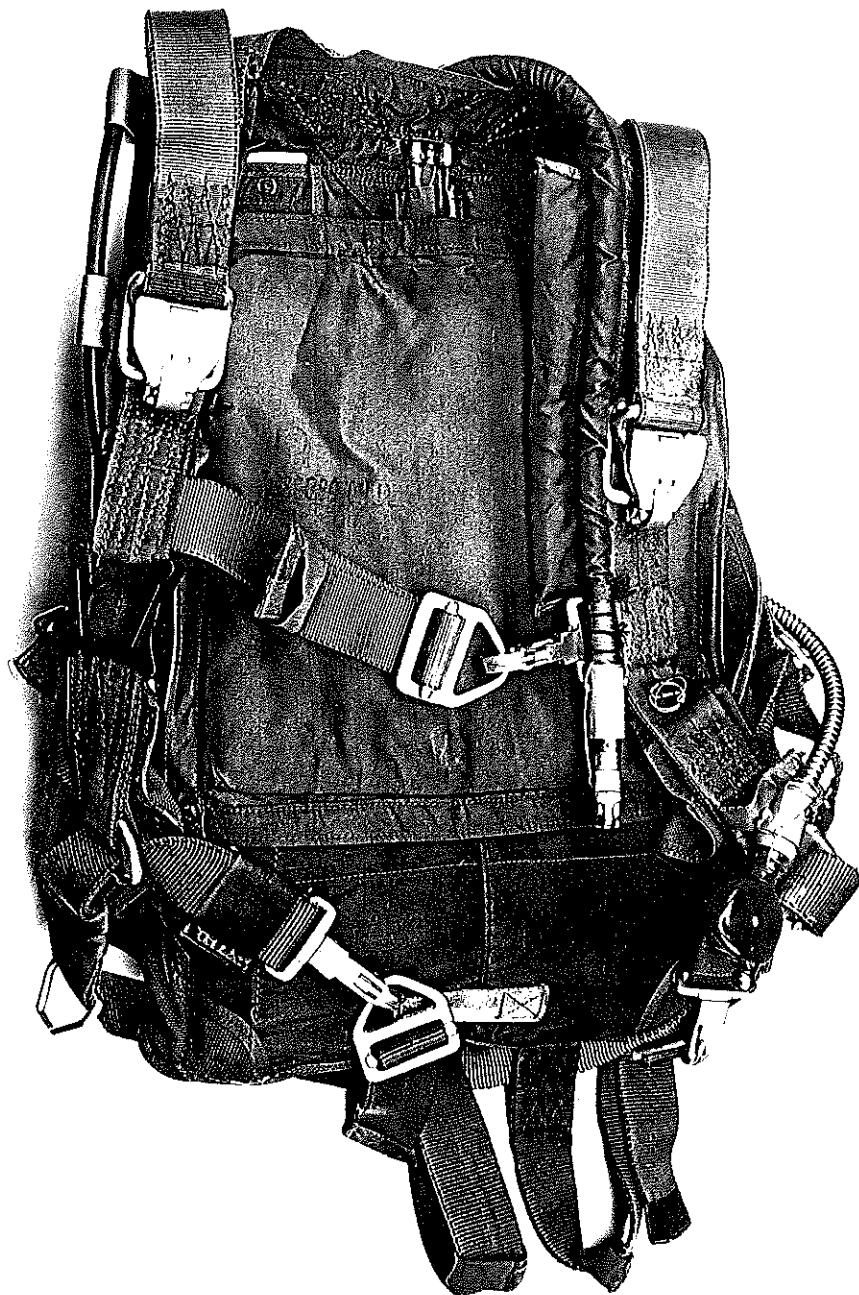
PICTURE 7. AN OVERALL VIEW OF THE MASTER REFERENCE 50C7024 (SERIES)
PARACHUTE HARNESS AND PACK ASSEMBLY
USED IN THE ANALYSIS OF THE ARTIFACTS.

Picture 7 below, is an overall view of the Master Reference Type 50C7024 (Series), Parachute Harness and Pack Assembly used in the analysis of the artifacts for this report.

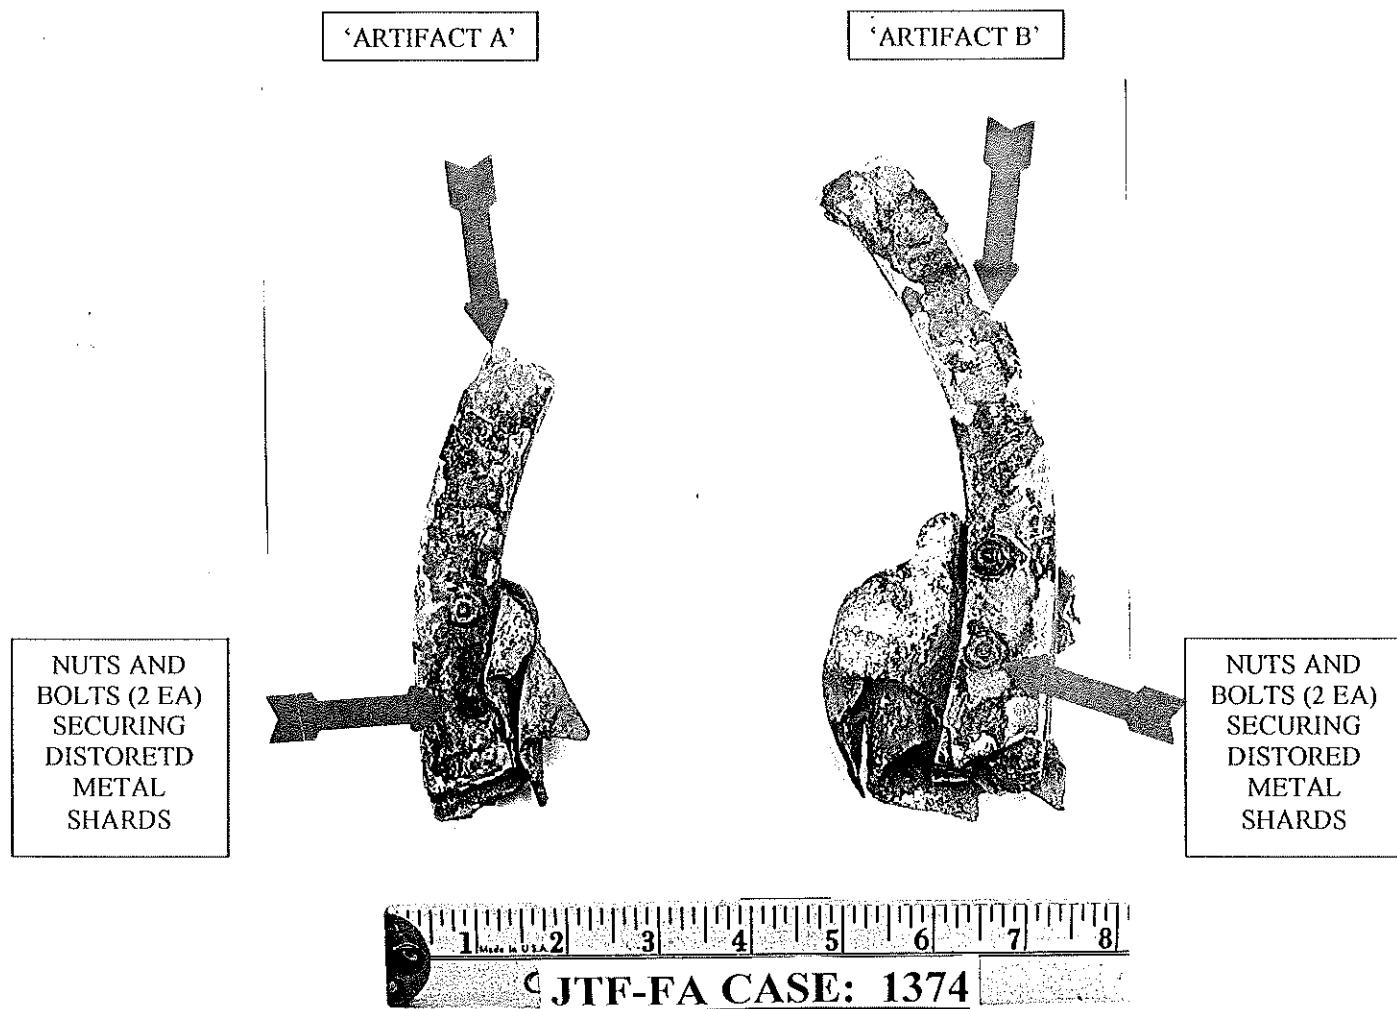
PICTURE 1. THE AMALGAMATED EJECTION SEAT ARTIFACTS SUBMITTED FOR ANALYSIS, WITH OPPOSING NUT AND BOLT HARDWARE SECURING DISTORTED METAL SHARD REMNANTS.

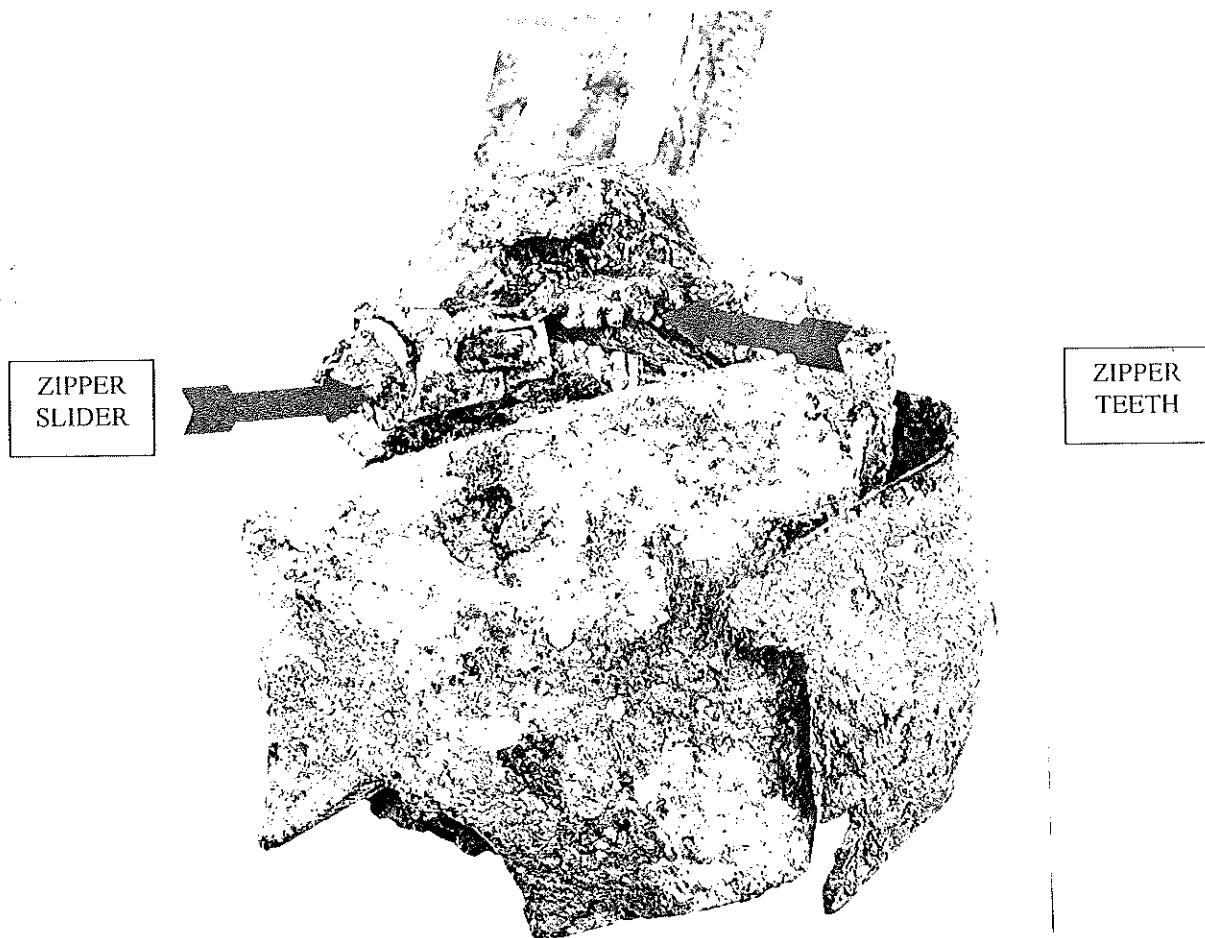
PICTURE 3. A CLOSE-UP VIEW OF 'ARTIFACT B' HIGHLIGHTING THE
PRESENCE OF ZIPPER TEETH AND A ZIPPER SLIDER
ON THE FABRIC REMNANT.

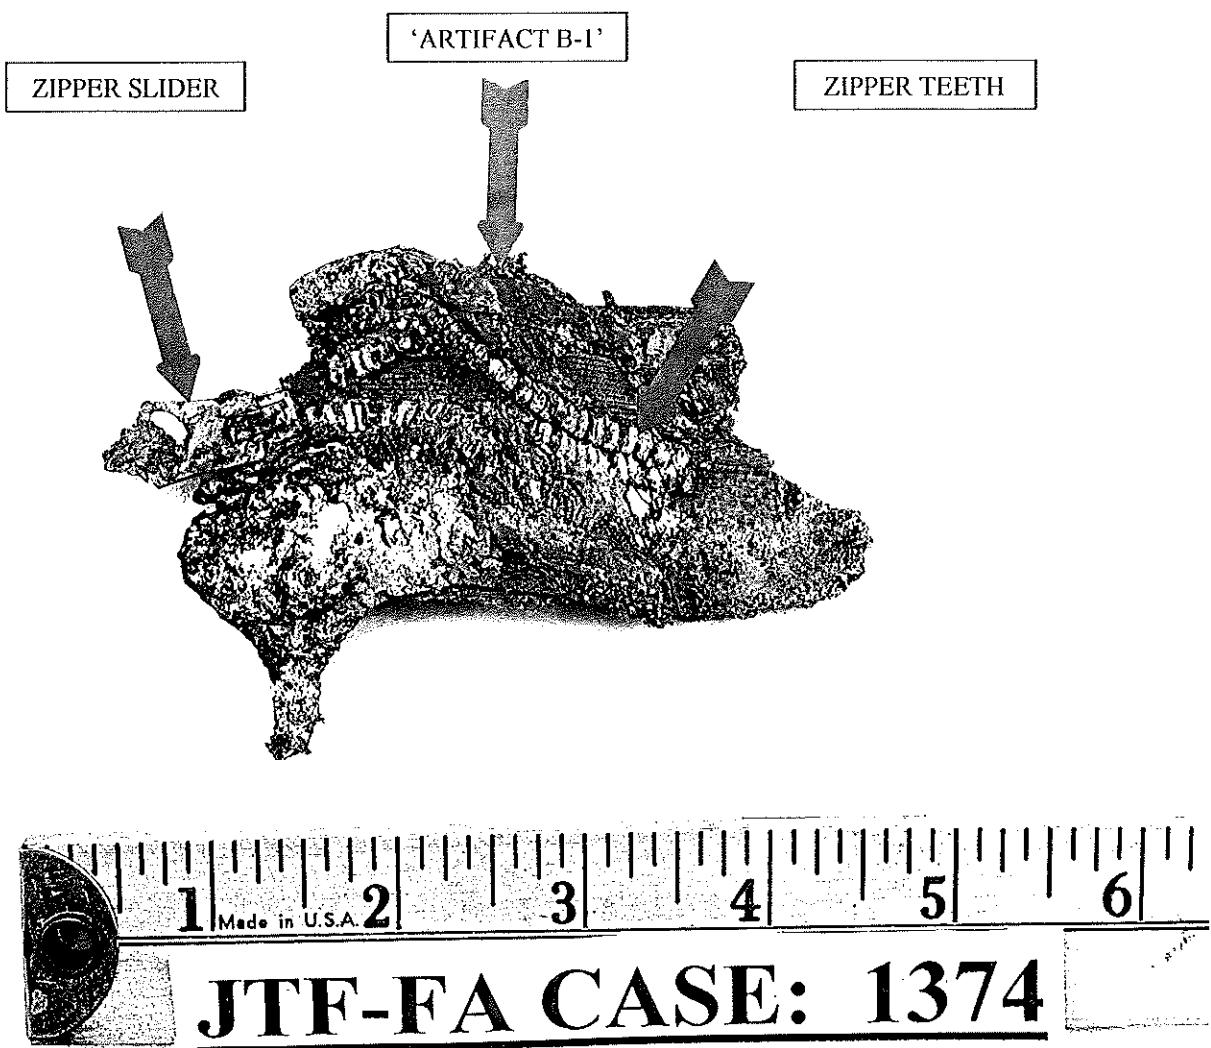
PICTURE 5. A CLOSE-UP VIEW OF THE FABRIC REMNANT ('ARTIFACT B-1') THAT WAS REMOVED FROM 'ARTIFACT B'.

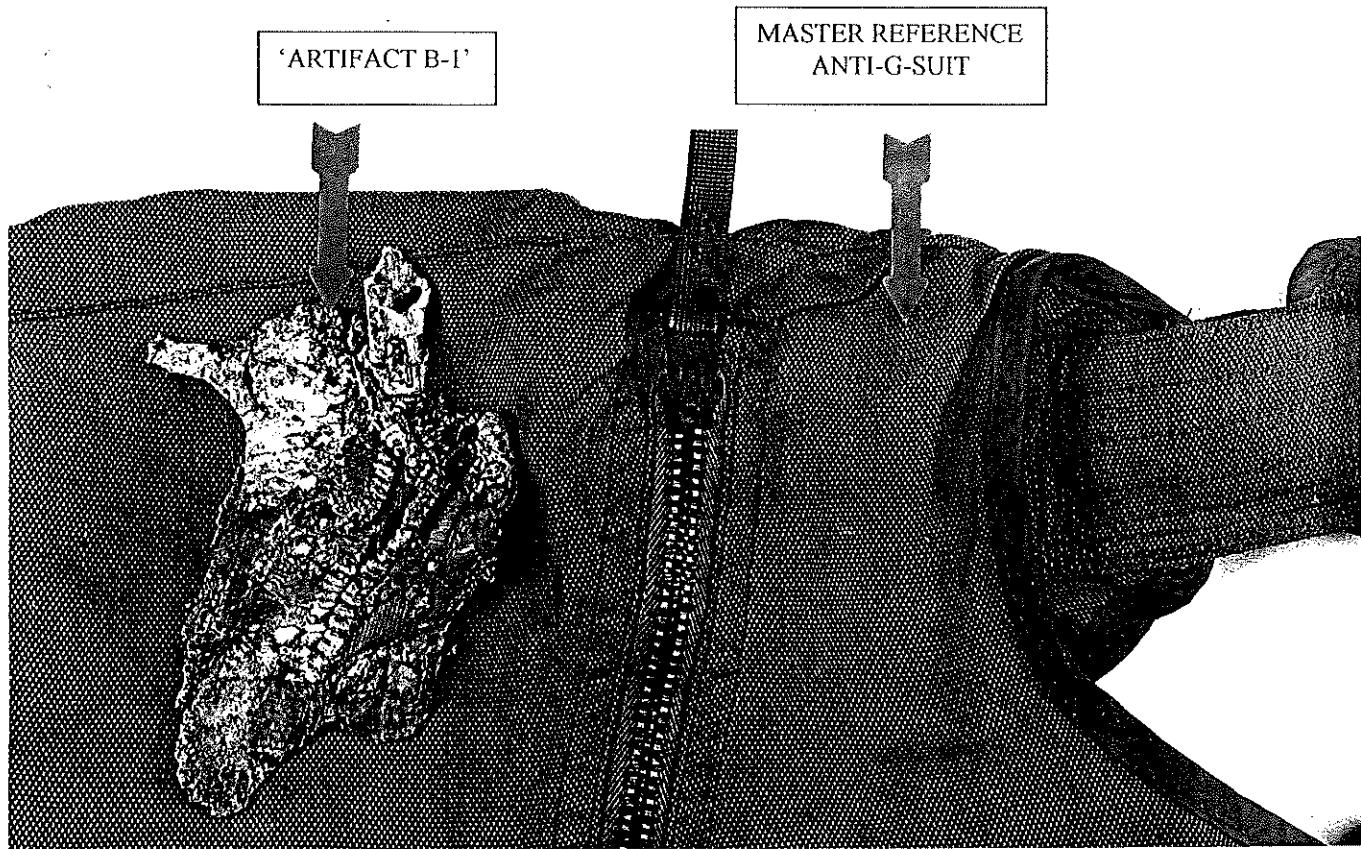
PICTURE 6. A VIEW OF 'ARTIFACT B-1' POSITIONED NEAR AN AREA OF ORIGIN ON THE LOWER RIGHT LEG SEGMENT OF A MASTER REFERENCE ANTI-G SUIT.

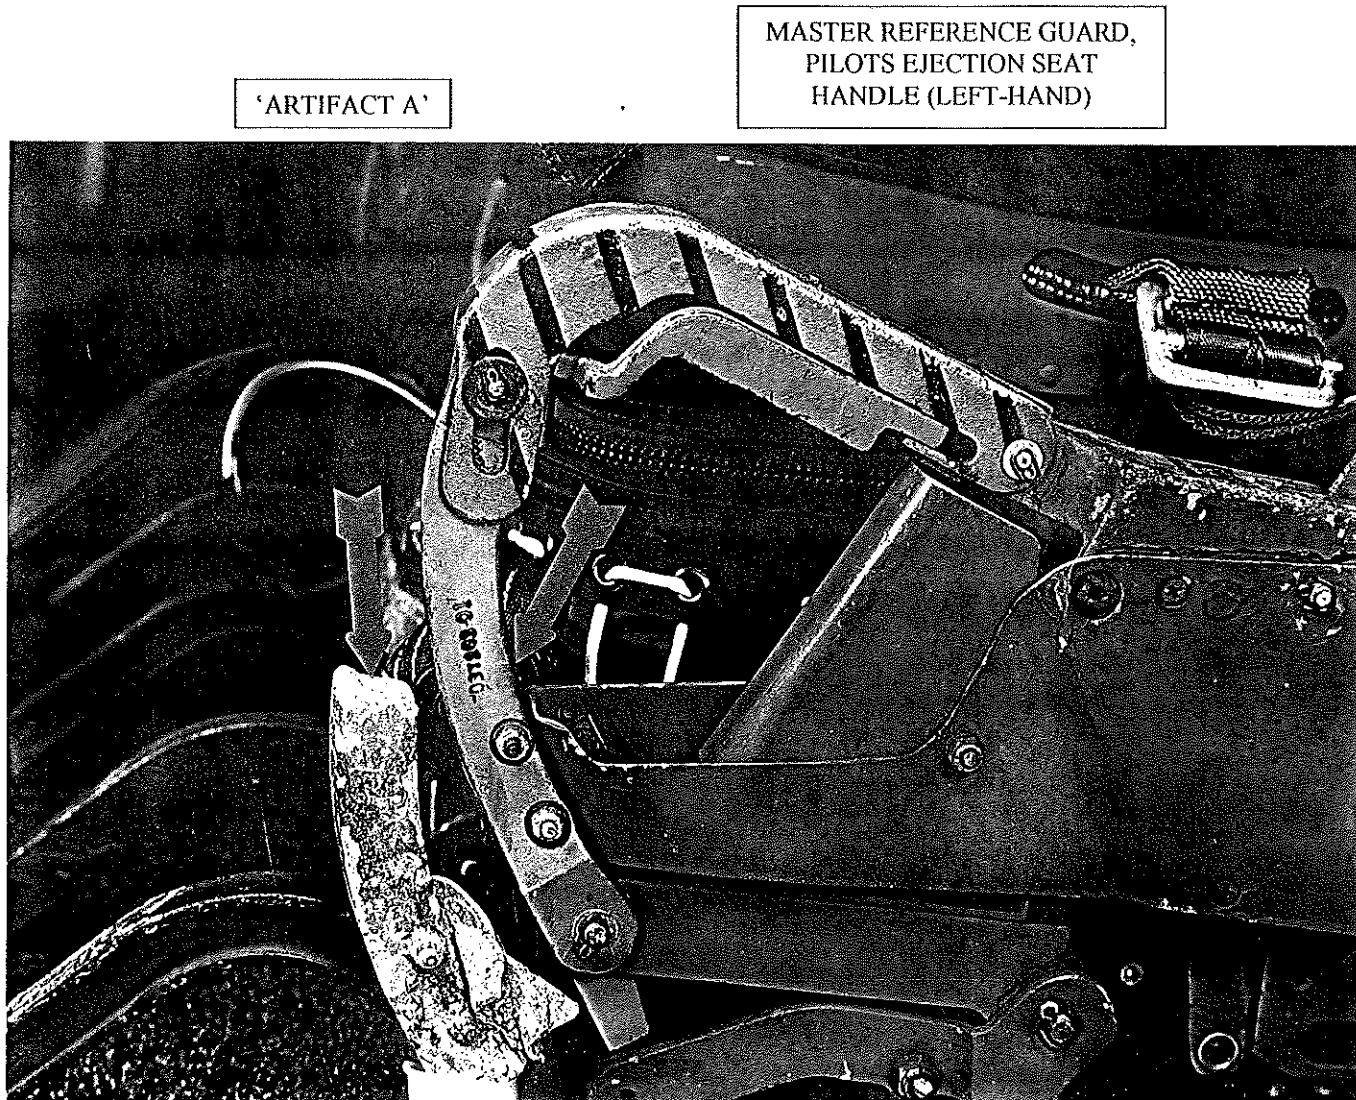
PICTURE 7. A VIEW OF 'ARTIFACT A' POSITIONED ADJACENT TO A MASTER
REFERENCE GUARD, PILOT'S EJECTION SEAT HANDLE
(PART NUMBER 7037363-02 – LEFT-HAND).

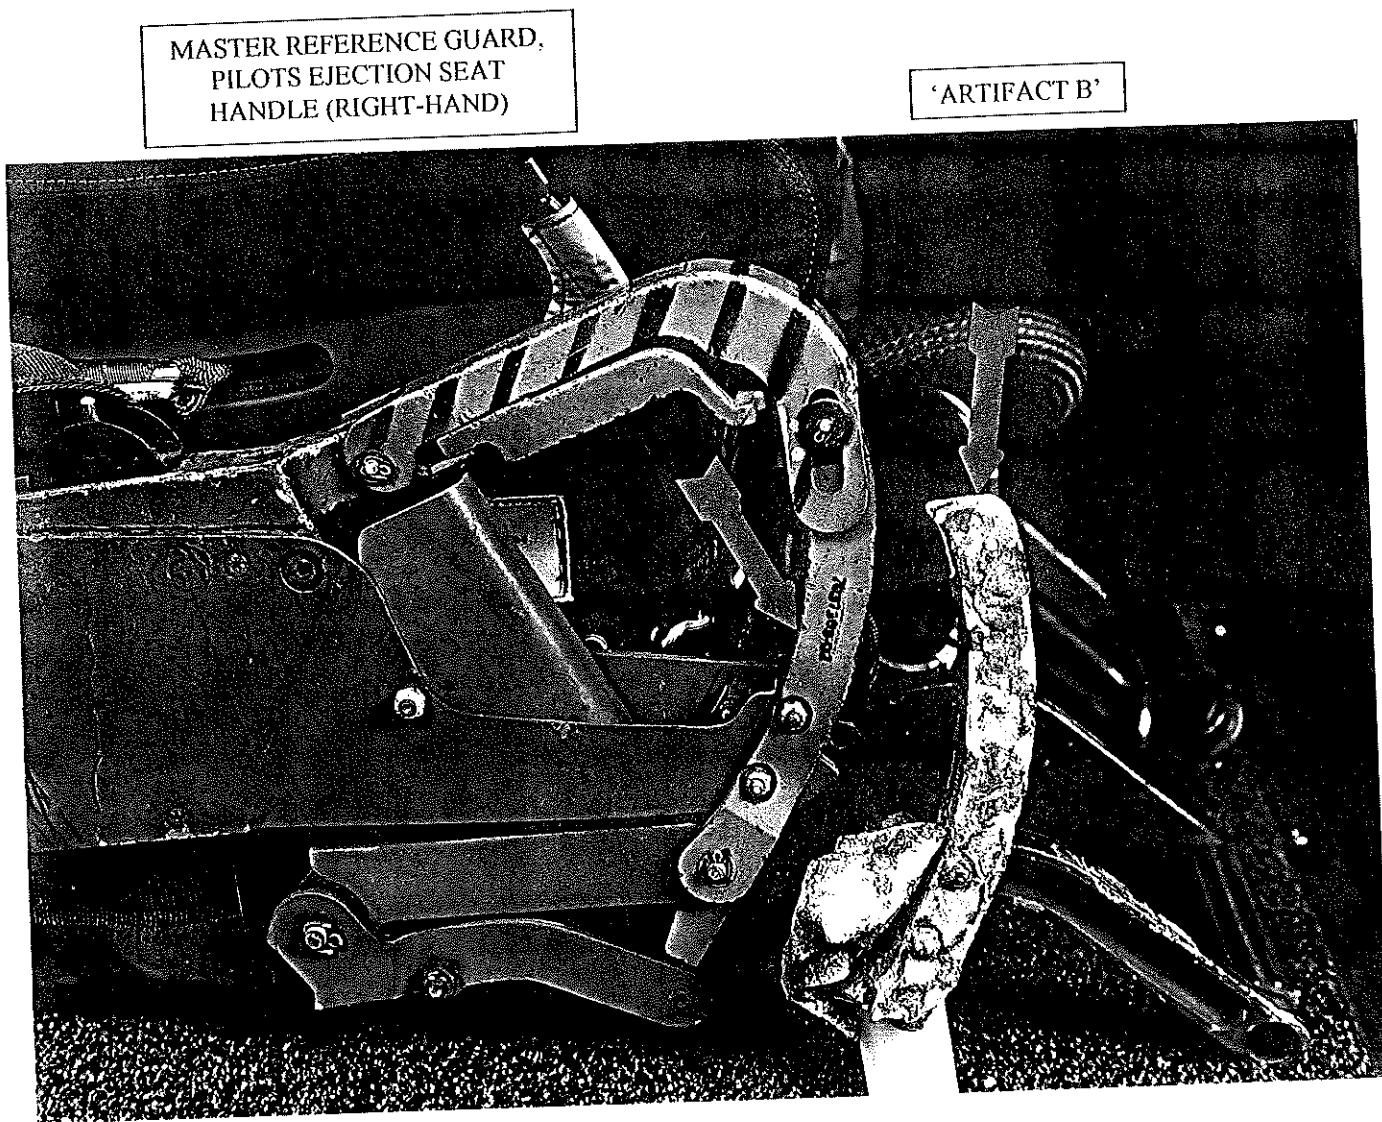
PICTURE 8. A VIEW OF 'ARTIFACT B' POSITIONED ADJACENT TO A MASTER
REFERENCE GUARD, PILOT'S EJECTION SEAT HANDLE
(PART NUMBER 7037363-01 – RIGHT-HAND).

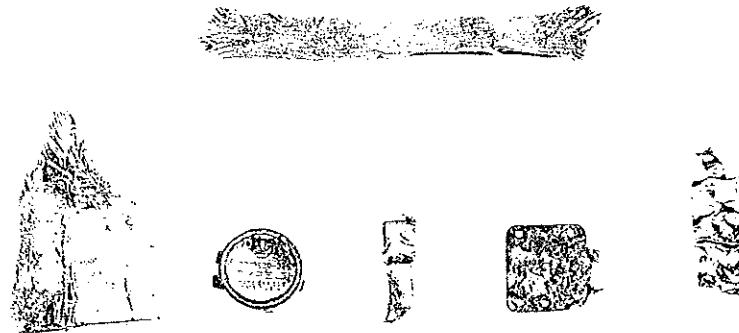
ARTIFACT BAG:
NUMBER - 3B

JTF-FA CASE 1374 ARTIFACT BAG: NUMBER 3B	
Item	Fragment Quantity
5 1/2 Inch Webbing Remnant	1
Fiber Glass Remnant	1
End Cap with Alpha/Numerical Data	1
Shielded Thermal Coupling Remnant with Alpha/Numeric Data	1
1 1/4 x 1 1/4 Inch Metal Remnant	1
Light Weight Aluminum Remnant with Alpha/Numeric Data	1

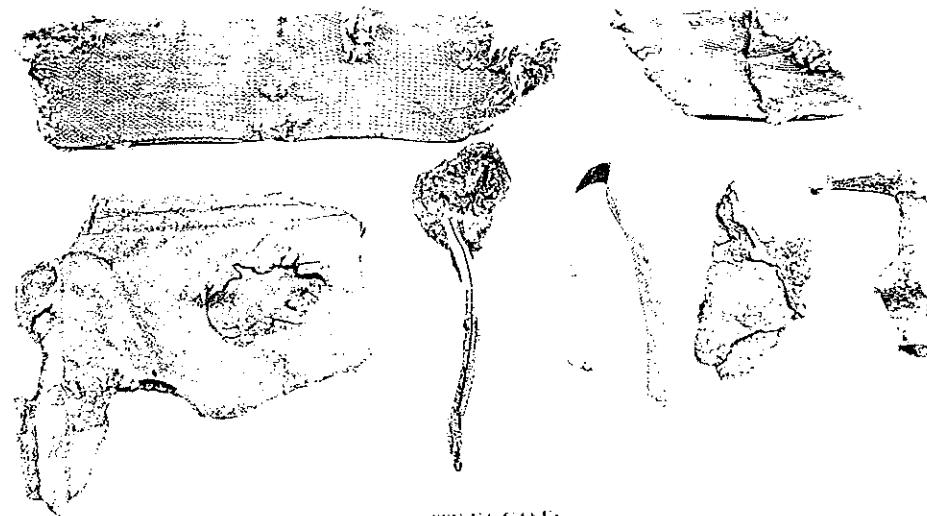
ARTIFACT BAG:
NUMBER - 4

Item	Fragment Quantity
Lap Belt Webbing Remnants	2
Possible Parachute Lowering Device	1
Pocket Remnant	
6 Inch Webbing Remnant with Box-X Stitch Pattern	1
10 Inch Webbing Remnant	1
Possible Parachute Container	1
Webbing Remnant	
Interdictor Lever	1

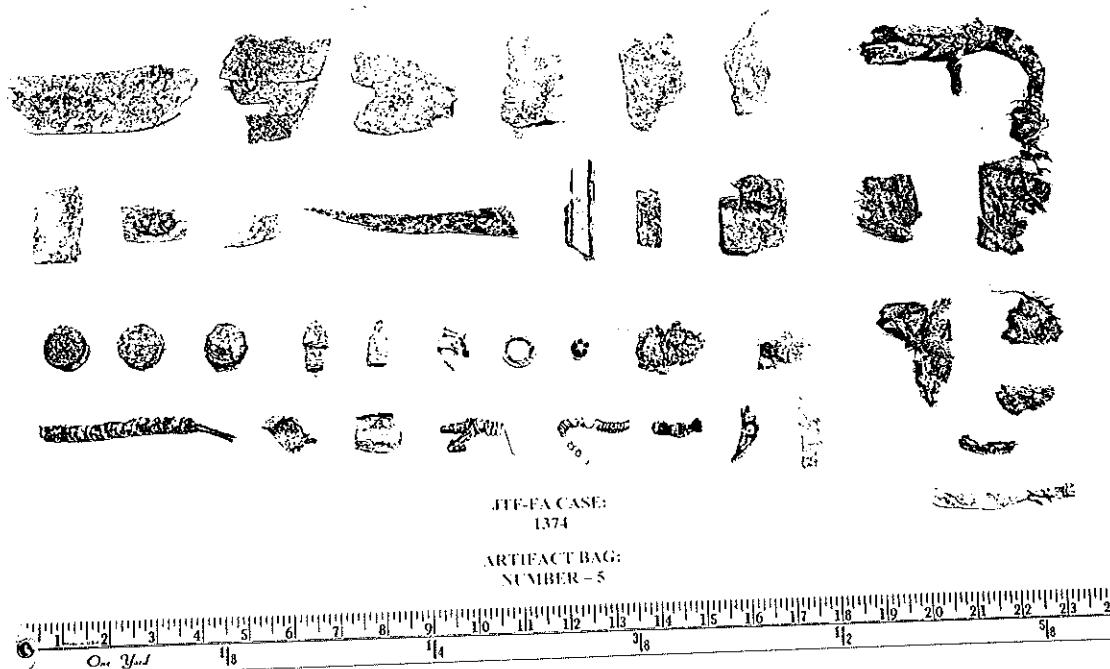
PICTURE 12. ARTIFACT BAG: NUMBER 5.

JTF-FA CASE 1374 ARTIFACT BAG: NUMBER 5	
Item	Fragment Quantity
Metal Remnants	6
Hard Rubber Hose with Fabric Sleeve	1
Metal Remnants	3
5 Inch Plastic Remnant	1
Red Rubber Remnant	2
Fiberglass Remnant	1
Fabric Remnants	7
Miscellaneous Snaps, Springs, Grommets, and Small Artifacts	18

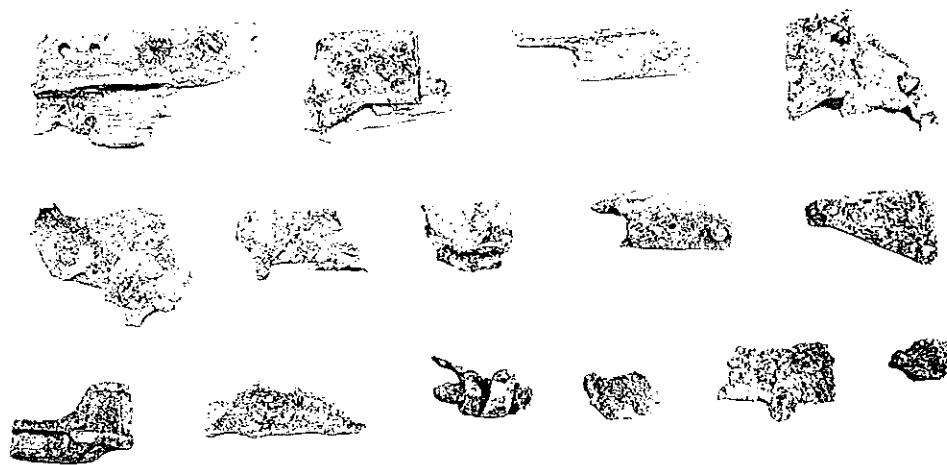
ARTIFACT BAG:
NUMBER - 5A

Item	Fragment Quantity
Metal Shards	15
