**Final Search and Recovery Report CIL 2009-149, an F-100D Crash  
Site Associated with REFNO 1374, Ban Phoun Village, Vilabouli  
District, Savannakhet Province, Lao People's Democratic Republic,  
20 October Through 14 November 2009**

**JPAC CENTRAL IDENTIFICATION LABORATORY**

**29 December 2009**

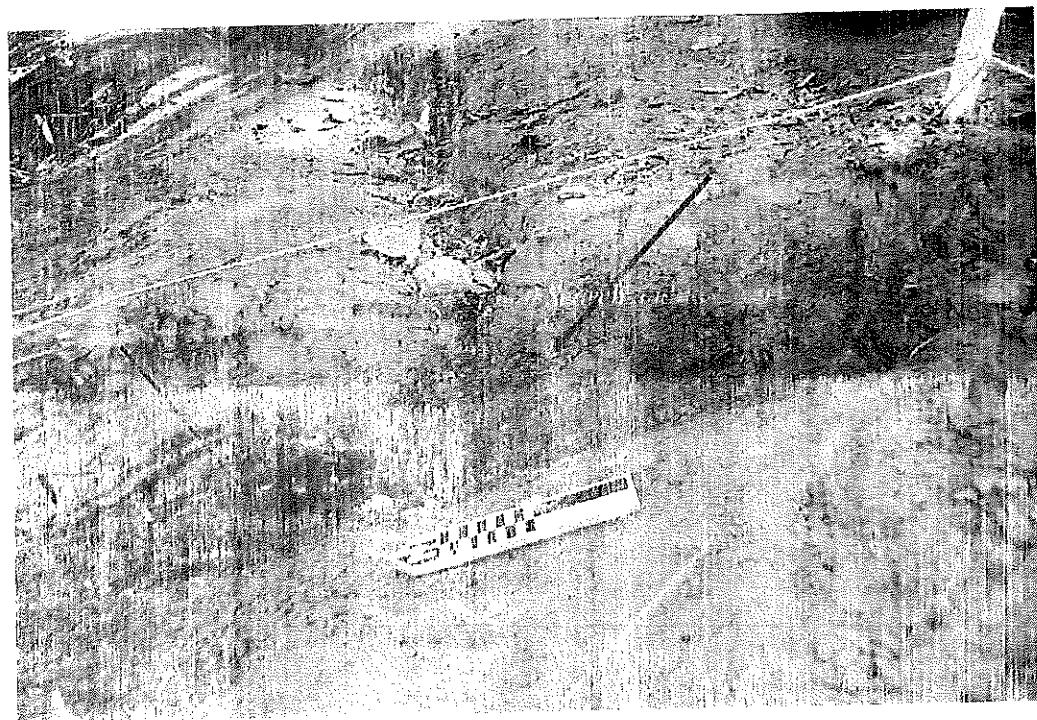
**Figure 6:** 100' east of point 1000' E of 400N-400E, view east illustrating deposition of mixed scree and talus armor sediments (blue arrow) overlying incident sterile soil (red arrow).

The third exception to excavating a buffer unit relates to units 496N-496E, a 4-x-4-m unit and 500N-496E, a 2-x-4-m unit. As noted above, this area appeared to be within the 272 square meters excavated in 1992. In unit 496N-496E (Figure 6), a 20 cm deep cap of mixed basal clay and upper sediments overlay the tan sandy clay that was consistently interpreted as the incident sterile horizon throughout the site (Figure 6). This horizon was a brown sandy loam typically present in undisturbed areas of the site and was notably missing, indicating that it had been removed at some point, most likely through the mechanism of the 1992 excavations. In 500N-496E there was a mixed layer of sediments overlying the tan sandy clay (Figure 7). These sediments were unconsolidated, granular, and had the appearance of screened sediments. Two significant items were recovered from the excavated fill, a small fragment of zipper and a safety pin clasp. Both of these items were small enough to pass through a one-quarter inch screen and most likely represent a loss during screening. A buffer to the east of both of these units was not excavated, as the eastern wall of both units exhibit a sediment profile indicating that the 1992 excavation continued to the east.

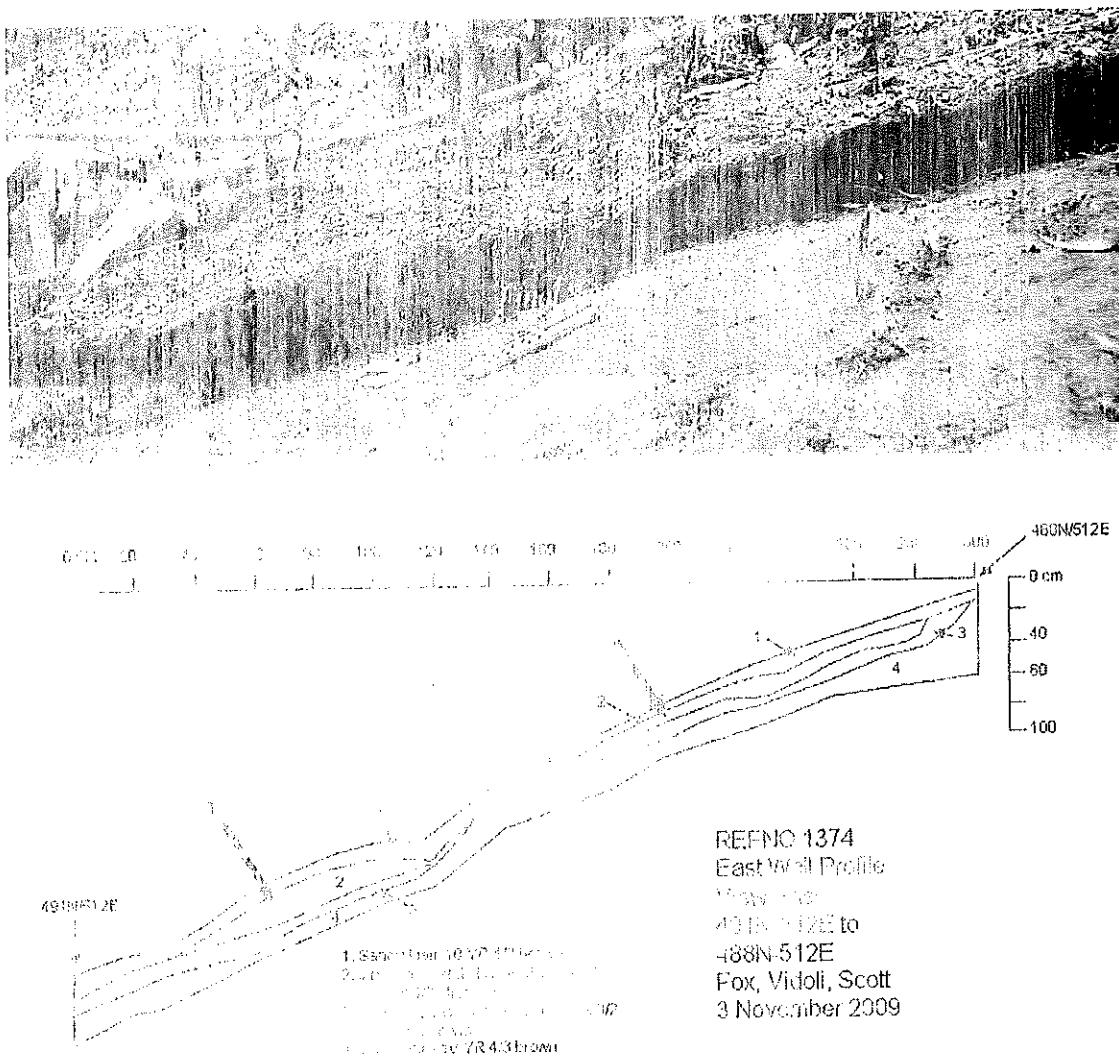
**Figure 9.** Soil profile, east wall of 488N-512E, view east. Red arrows indicate blast turbation-deposited sediments.

Further evidence that at least a portion of the bomb craters in and around the site post date the crash incident were revealed in a number of locations in their walls. Along the south wall of the excavations in the southwestern corner of the excavated area, large areas of basal clay overlie the pre-incident surface. The clay layers were sterile; however, aircraft debris typically occurred in the interbeds just below the clay layers.

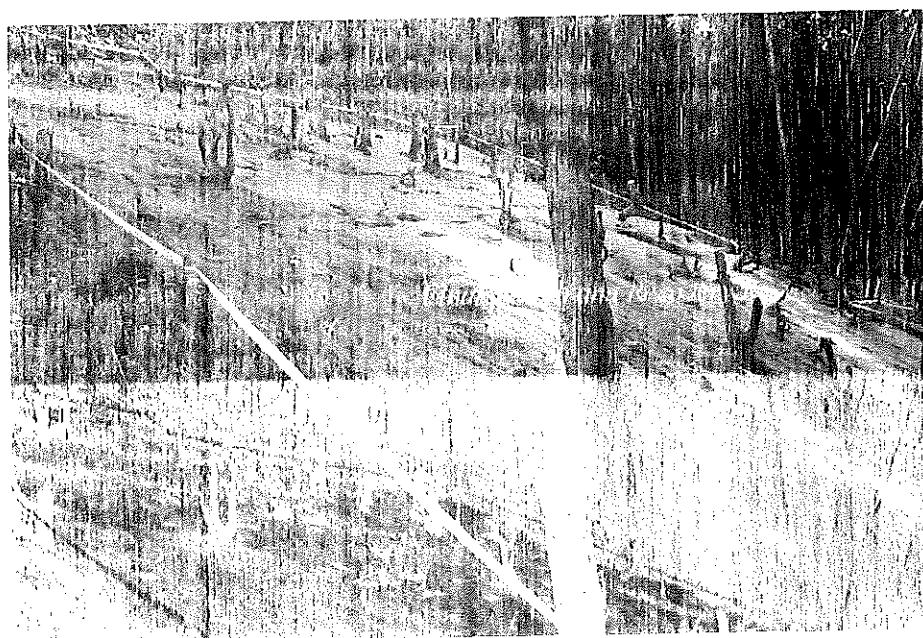
**Figure 11** A view down the long trench excavation to view south west. This area contained the main body of the site and evidence.
